A document prepared under the auspices of the Sixmile Creek Partners in preparation for a channel and watershed management plan.

MAY, 2007

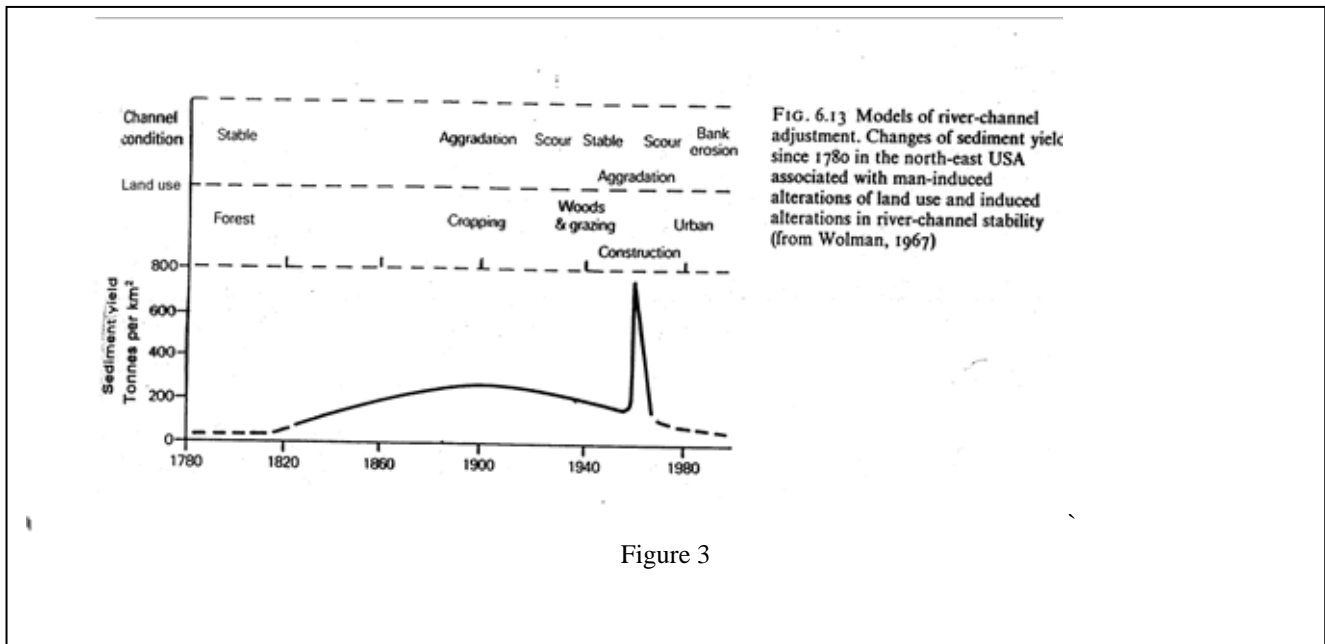
Figure 3 -- Models of river channel adjustment

Since the early 20th century, agricultural intensity has declined and that stored sediment is being removed by channel degradation and by increased channel sinuosity. Such behavior has been recognized in other streams in the eastern United States where similar cultural histories have occurred (Fig. 3).

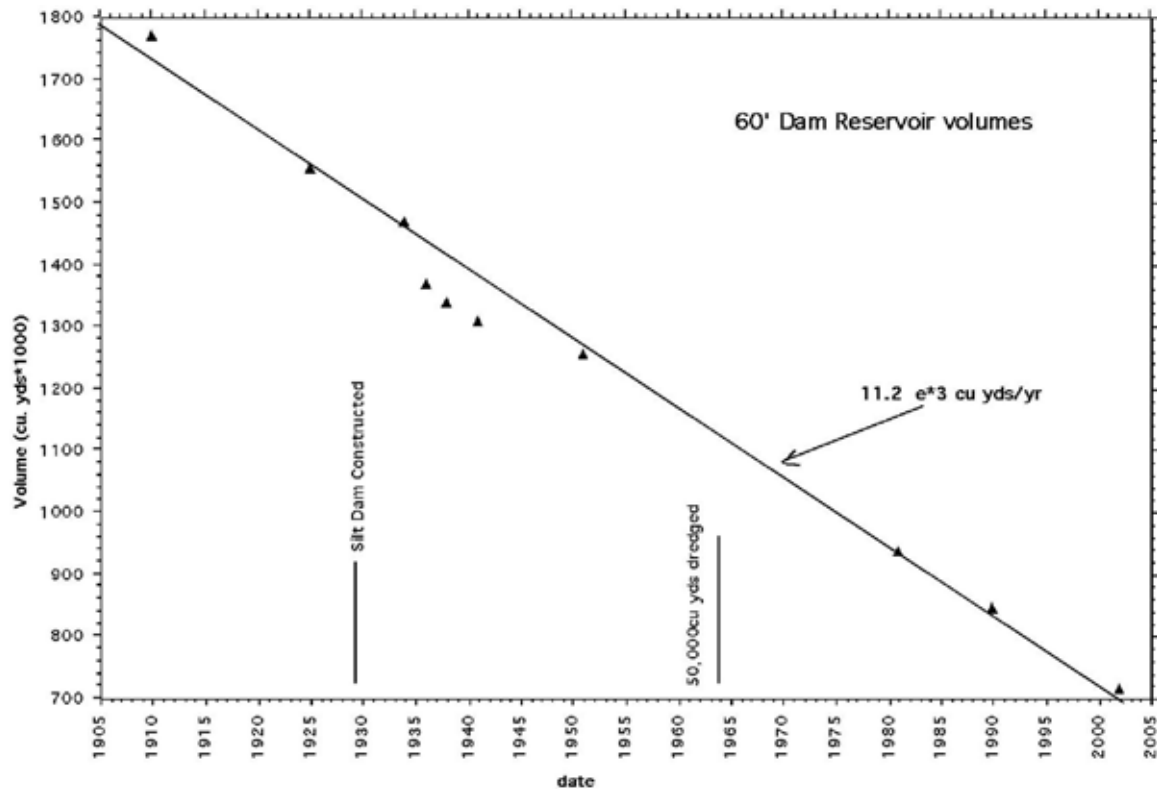
Figure 6. Volume of the City Water Supply Reservoir over its lifetime

Sediment deposition is directly related to erosion, but occurs in different areas and causes different problems. Sedimentation in the City of Ithaca water supply reservoir is the most serious economic problem in the watershed. Data in Fig. 6 show that if the linear rate of infilling of that reservoir continues, it will be completely filled in about 60 years. Because the drinking water intake is 20' below the reservoir surface, it would be useless as a water supply well before then. It is an important and unanswered question whether it is more economical to attempt to reduce erosion and sediment transport in the channel above the reservoir or to remove sediment from the silt dam and dredge the reservoir periodically.

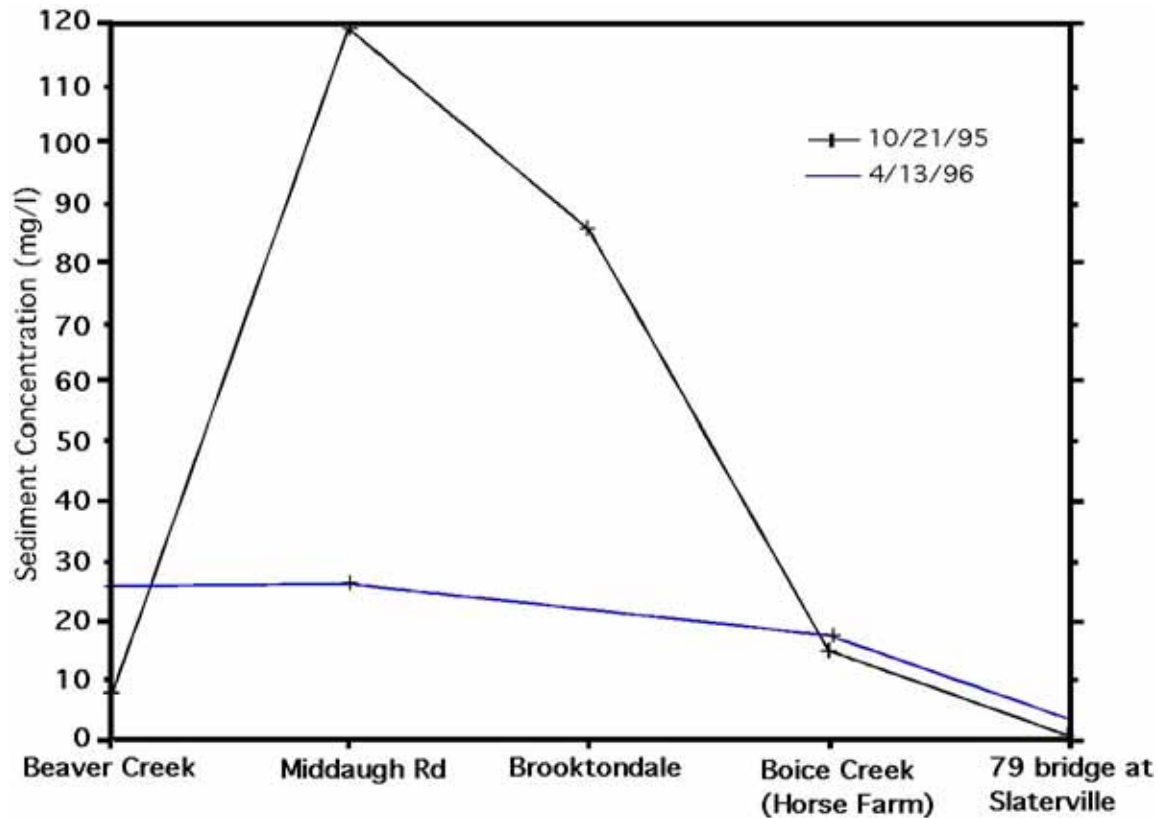
Figure 7. Values of suspended sediment concentrations along Sixmile Creek, and in the tributaries Boice Creek and Beaver Creek from Fabbri (1996). .

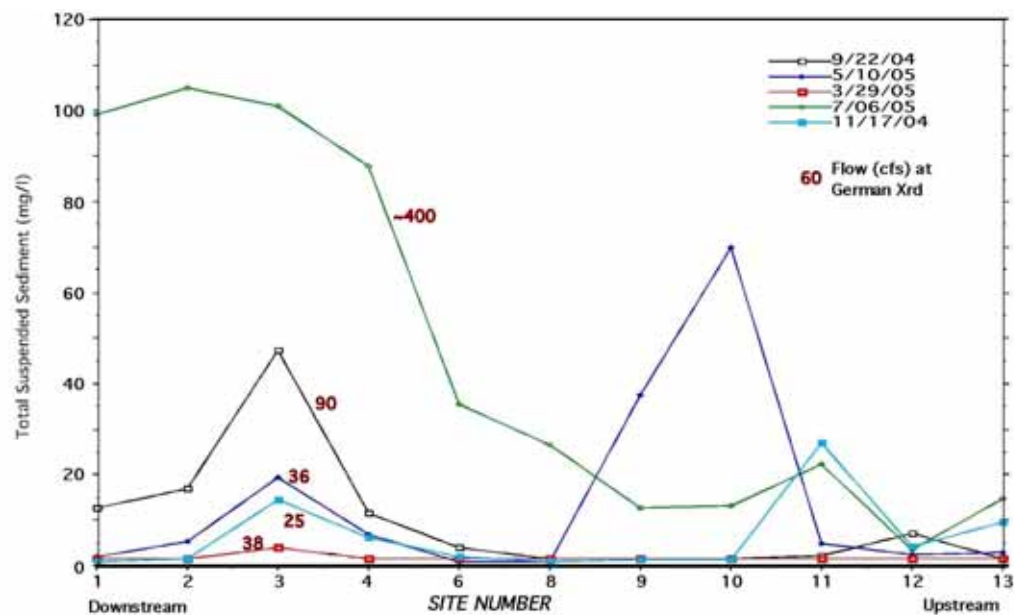
Figure 9. Suspended sediment concentrations along Sixmile Creek in 2004-05; data from Volunteer Monitoring Group (tributary sampling sites were omitted). Site locations are shown on Fig. 1.

A single high flow (~400 cfs) event in late March showed a very sharp increase in sediment concentration downstream from Brooktondale (site 6 on Fig. 9). Similar but much muted increases in this sector were also noted during most of the low flow sampling surveys. Downstream from the dams (sites 1 and 2), the TSS shows the expected decrease, or lack of continued increase. The automatic sediment samplers in the USGS gaging stations at Brooktondale and German Crossroad (Bethel Grove) provide suspended sediment data of quite a different type. Daily mean flows are combined with the sediment data to produce a record of daily suspended sediment load (in tons/day) over time. Data for the water year 2004 (10/1/04 to 9/30/04), which was wetter than average, are the most complete available

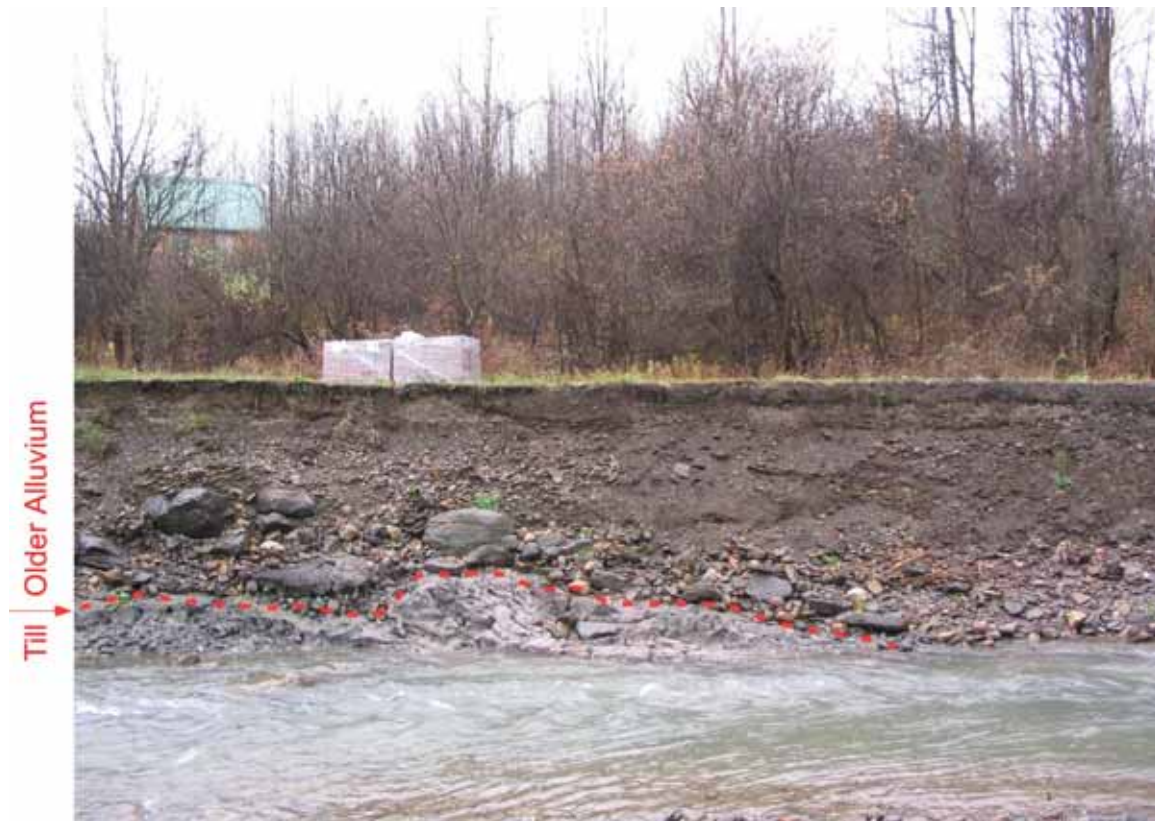
Figure 12. Cutbank with thick deposit of older (300-400yrs b.p.) alluvium overlying till just upstream from German Crossroad.

Another large reservoir of bedload is the older alluvium stored along the main channel and tributaries and exposed in their banks. For example, above German Crossroad an eroding cutbank exposes about 6 ft of older alluvium overlying 3 to 4 ft of till. (Fig. 12). In contrast to till exposures, this stored alluvium consists almost entirely of older bedload material and, when supplied to the channel, adds little suspended sediment.

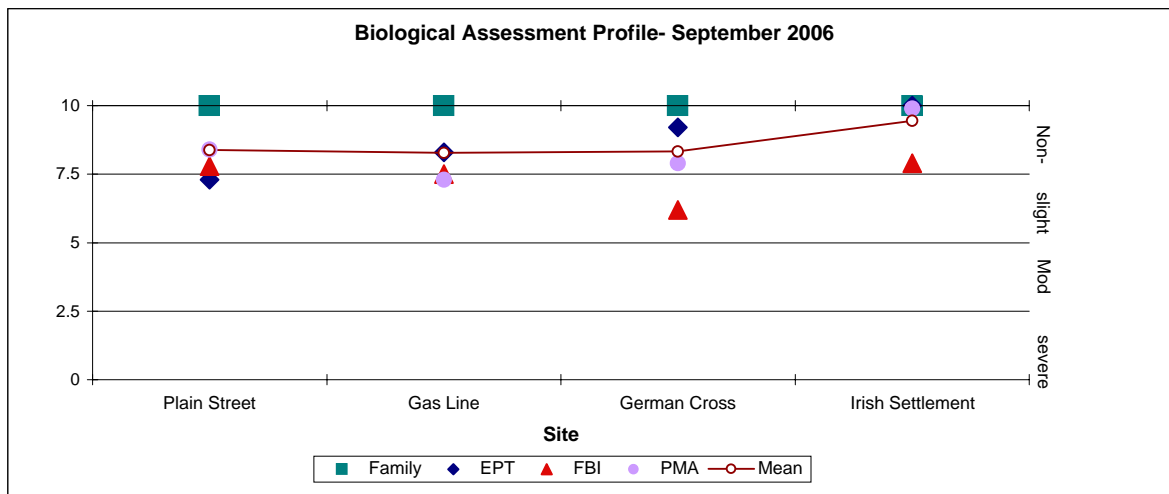
Figure 13. Results of biological assessment profile of Sixmile Creek (Metric for the 2006 BMI survey, see text for details)

According to DEC research, combining the metrics into the multimetric Biological Assessment Profile (the "mean" on Fig. 13) does consistently predict the level of impact to water quality 92% of the time when identifications are done to family level. In the 2006 survey, the mean is constant from Plain St. to German Crossroad, but rises significantly in the headwaters.
