Region 7 Aquatic Invasive Species Program  
Cayuga Lake  
2025

Emily Timkey-Benzinger, Aquatic Invasive Species Coordinator, Region 7  
NYS Department of Environmental Conservation  
Bureau of Invasive Species and Ecosystem Health, Invasive Species Coordination Section  
*in cooperation with NYS Water Resources Institute at Cornell University*

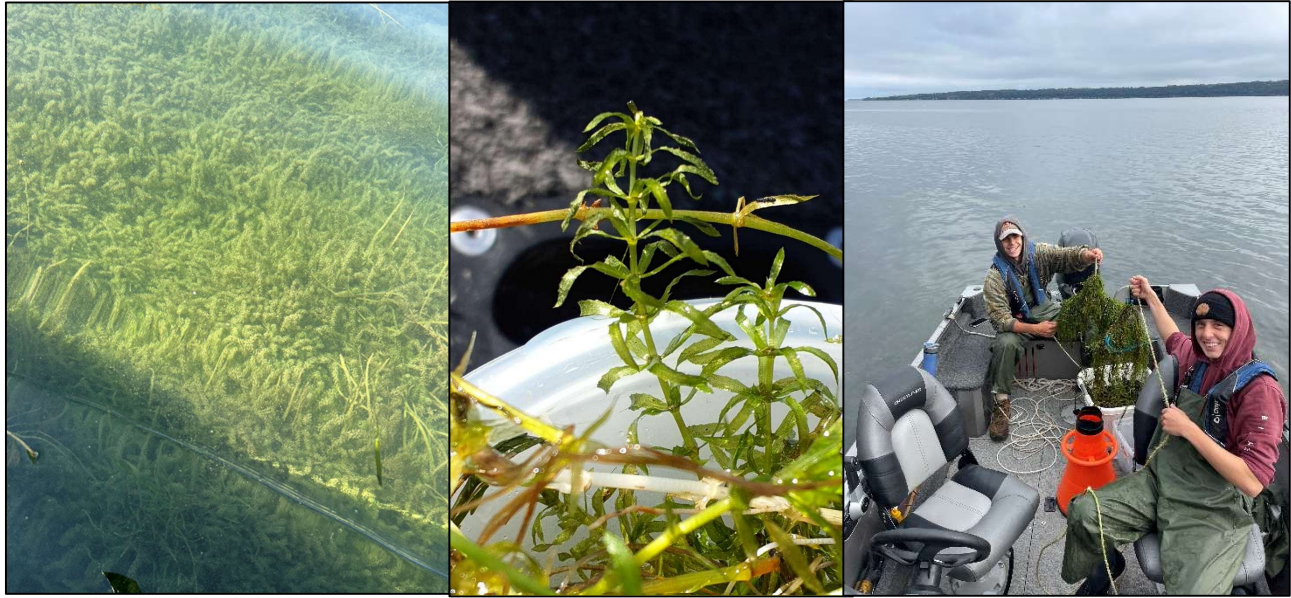
Figure 3. Left – Patch of hydrilla observed in Cayuga Lake. Hydrilla in this area is the only species present, excluding a trace amount of native eel grass. Center- close up of hydrilla observed in Cayuga Lake. Right – Region 7 AIS Team members surveying for hydrilla on Cayuga Lake.

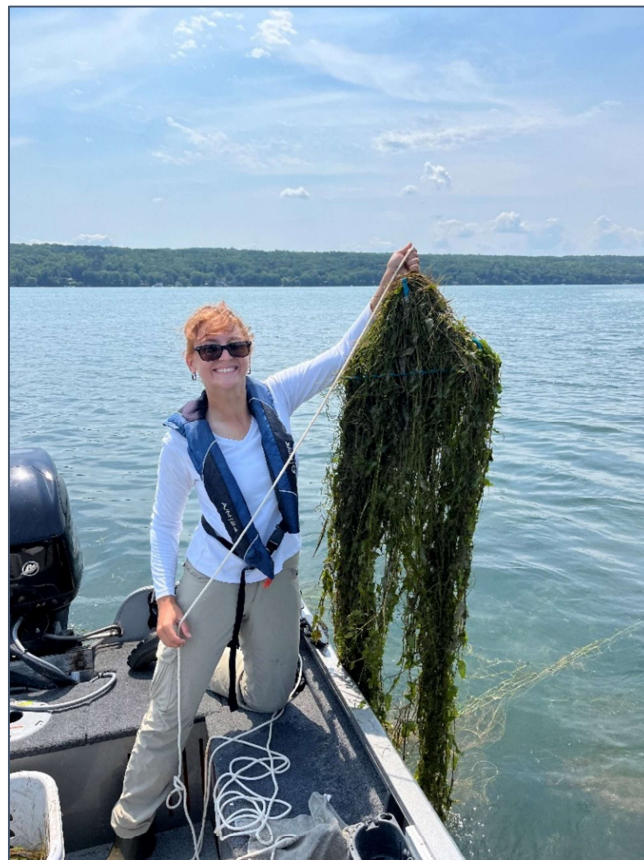
Figure 4. Region 7 AIS strike team member pictured with a “dense” rake of submerged aquatic vegetation.

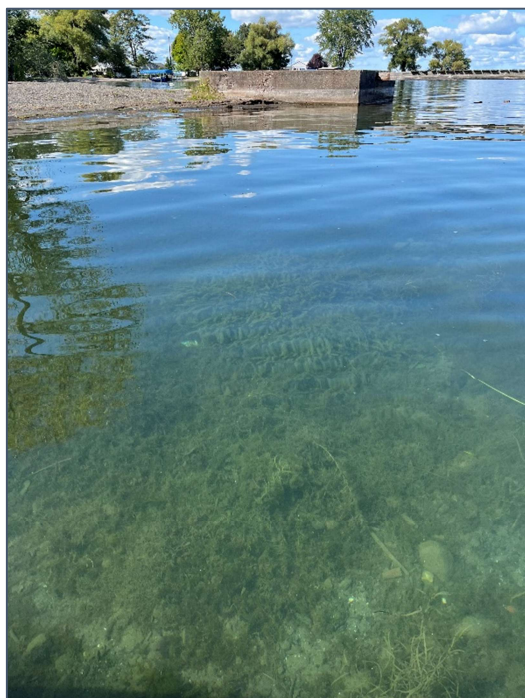
Figure 9. Hydrilla patch located at the Sheldrake Boat Launch

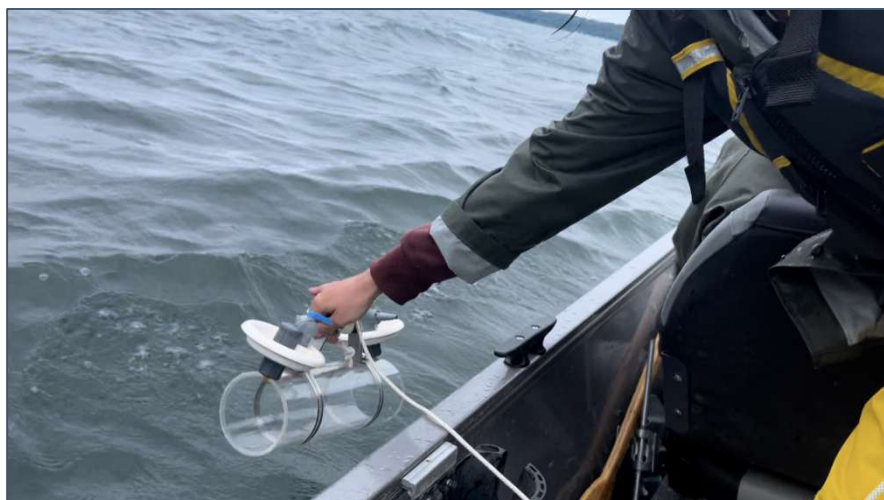
*Figure 11. Van Dorn Sampler used to collect deep water samples.*

To abide by product label and Aquatic Pesticide Use Permit conditions water samples were collected within the treatment zone and 0.5 miles south and 0.5 miles north of the application area. Samples were collected using Gold Standard ELISA kits and are analyzed by Community Science Institute (CSI), located in Ithaca NY. Water samples within the treatment areas are needed to determine if the desired herbicide concentrations are being maintained. Water samples collected outside of the application area are needed to determine if water use restrictions listed on the product label can be lifted. Water samples were collected 24-48 hours after each Sonar H4C application the by the Regional AIS Team, contractor, or partner.

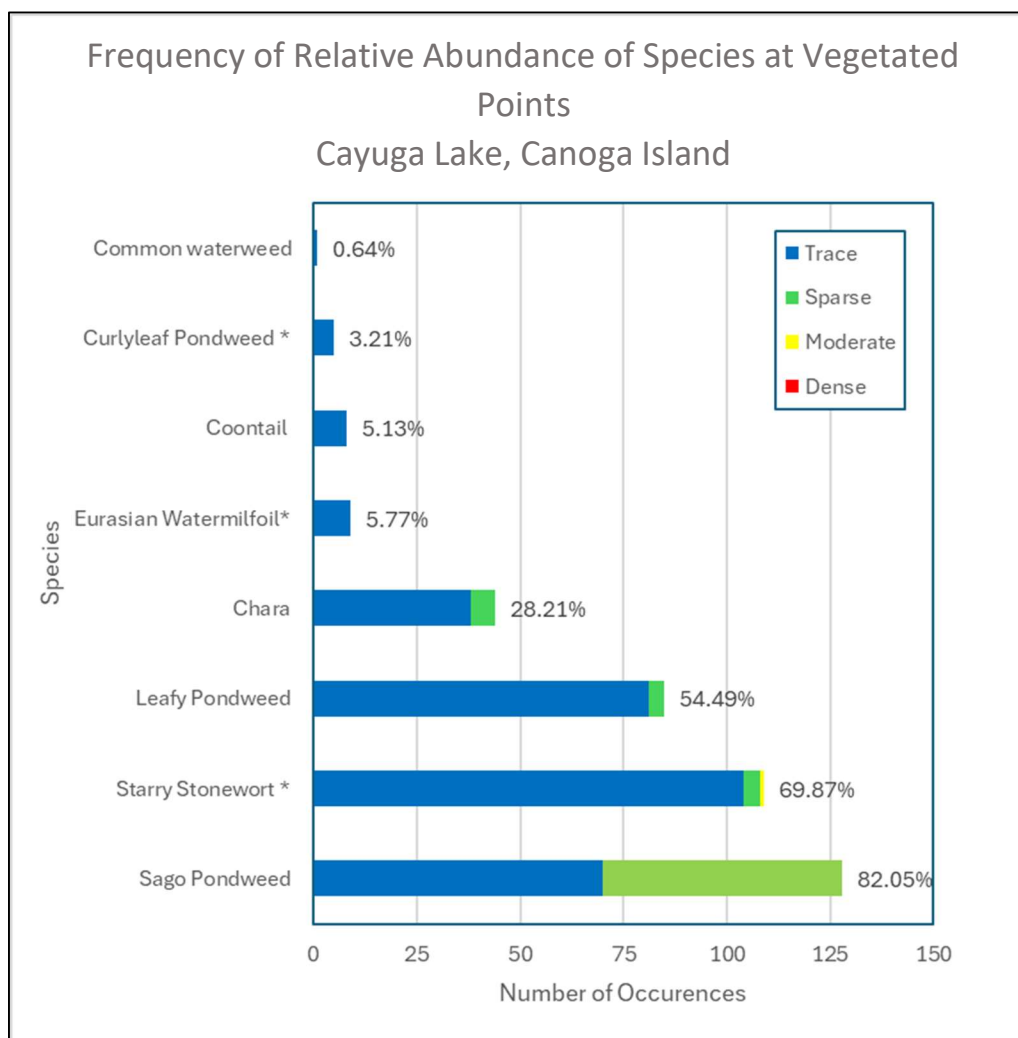
Figure B 4 Frequency of relative abundance of species at vegetated points at Canoga Island. Percentage represents the frequency that each species was observed on a vegetated rake toss. NOTE – Vegetation monitoring occurred in early June, when many submerged vegetation species have yet to emerge.

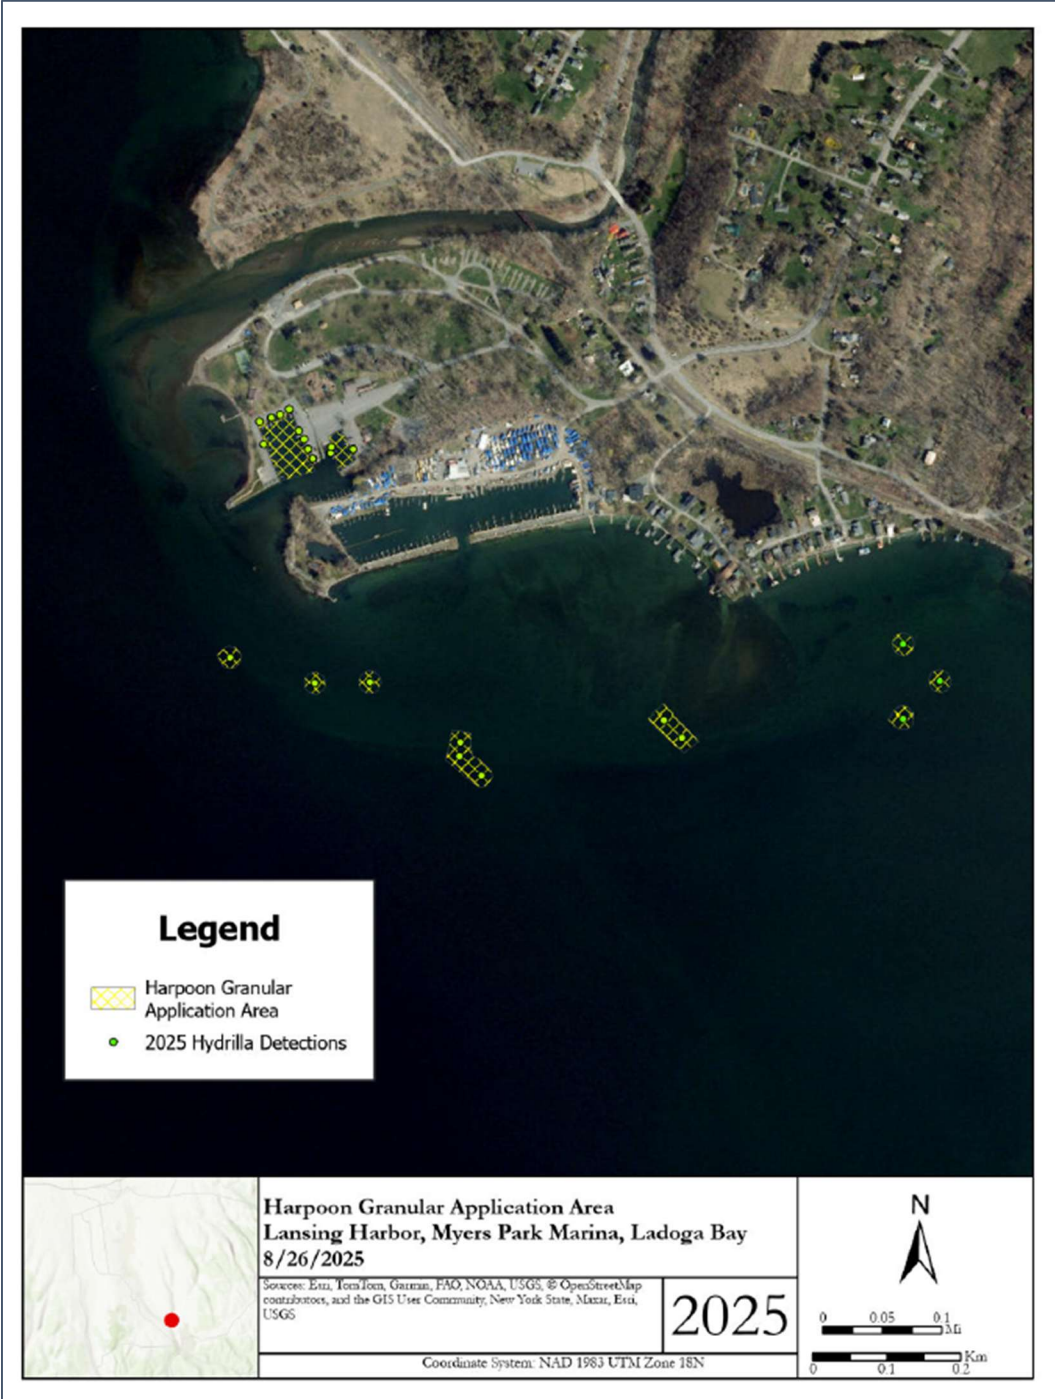
Figure C 3. Map of Harpoon granular application sites. Harpoon granular was applied in locations where hydrilla was detected during 2025 monitoring events.

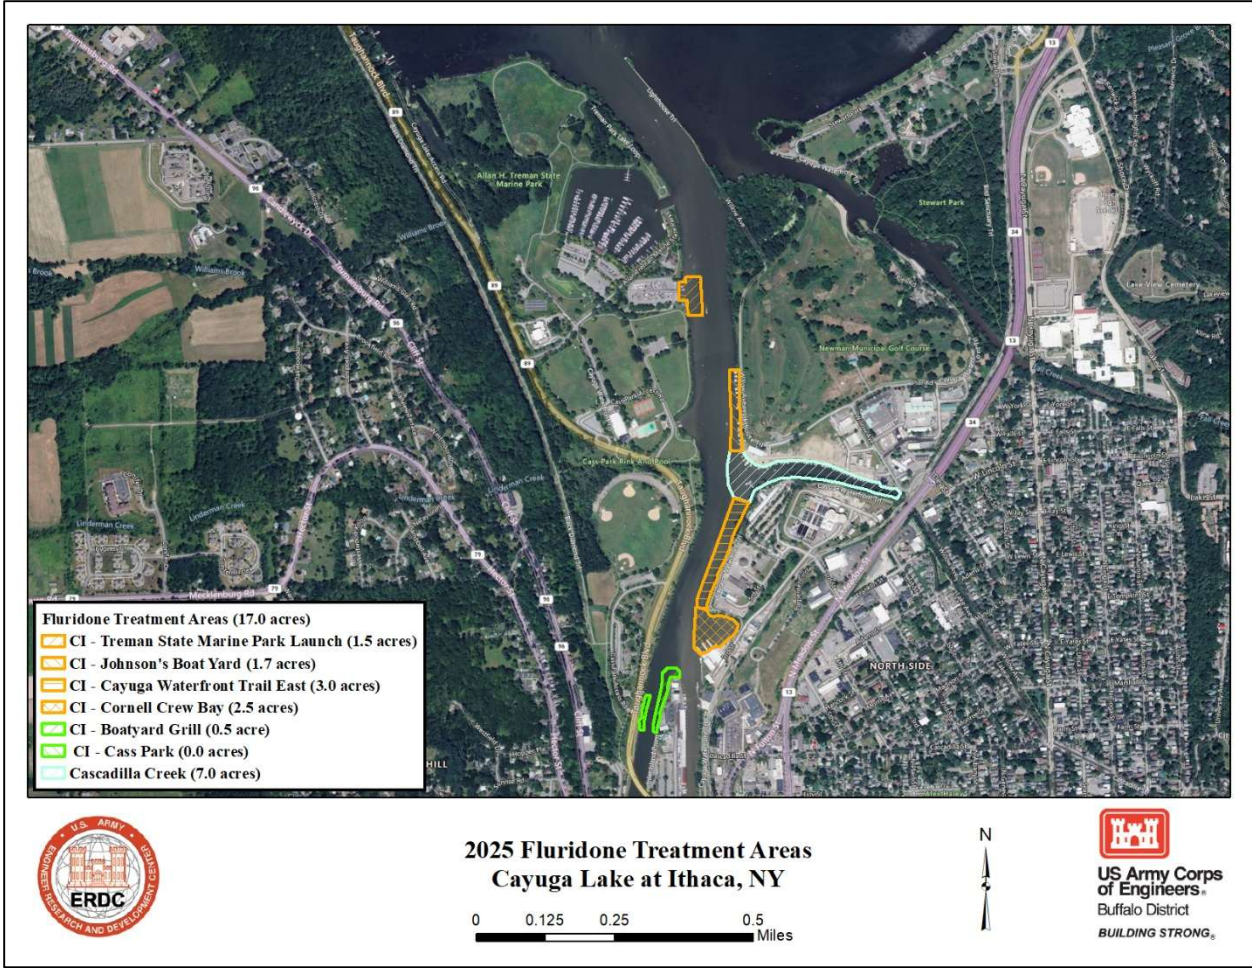
Figure C 9. US Army Corps of Engineers Cayuga Inlet and Fall Creek treatment areas.

The Sheldrake area was managed in response to hydrilla detections by AIS Strike team staff and FLPRISM monitoring. In 2025 a total of 222.9 acres were managed by NYS DEC via herbicide application over 4 different defined areas. Control areas include South Aurora, Long Point, Sheldrake Point, and Lansing Harbor, Myers Park Marina, and Ladoga Bay (**Figure 7 & Appendix C**). Additionally, USACE coordinated herbicide application in 2 locations, the North Aurora Area and Cayuga Inlet (**Figure C9** and **Figure C10**).

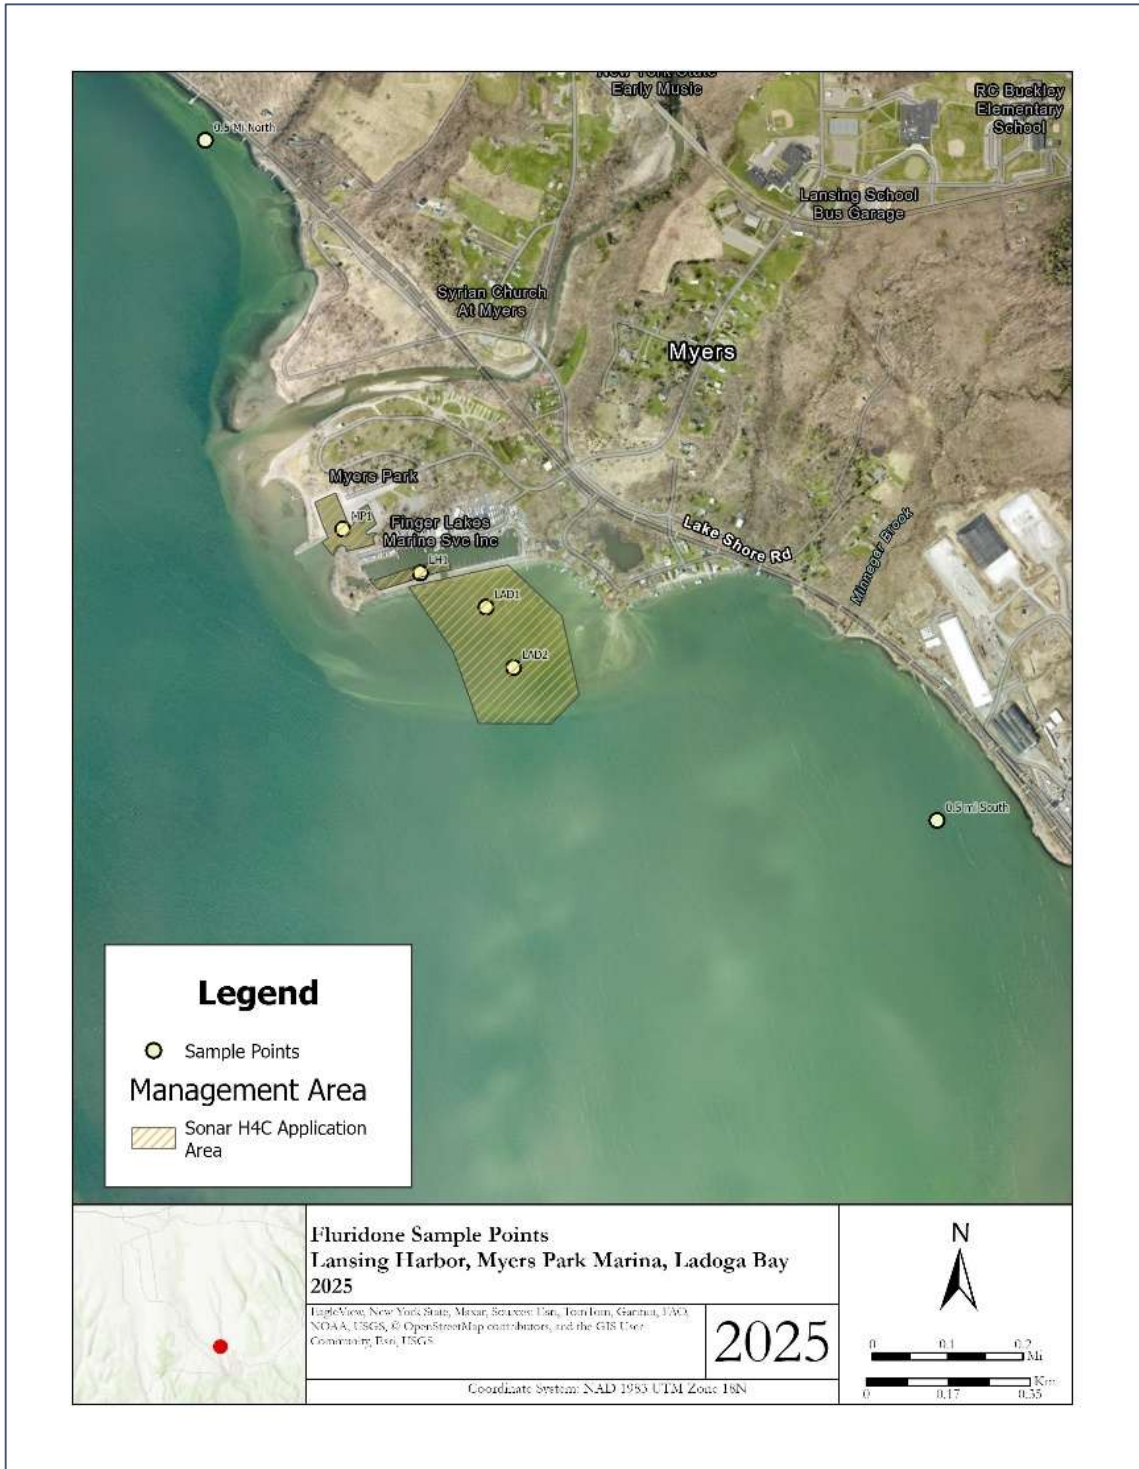
Figure D 3. Water sample points at Myers Park Marina, Lansing Harbor, and Ladoga Bay. An additional water sample was taken from the office tap at Finger Lakes Marine Service.

Table D 2. Fluridone sample results for Myers Park Marina, Lansing Harbor, and Ladoga Bay. 0.5 Mi South Sample Point collected on 6/26/25 came back above the 1.0 ppb threshold due to assumed contamination, as the same boat used to collect samples was the boat used for herbicide application.

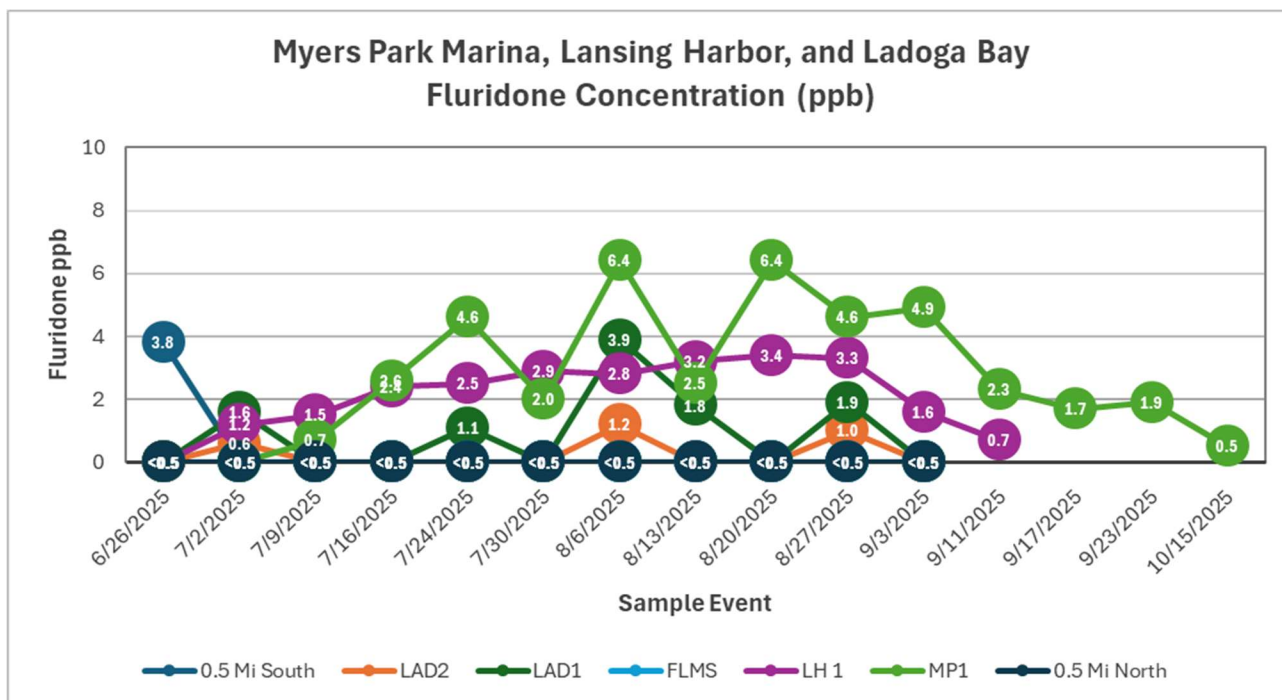
Figure D 1. Graph of fluridone concentrations over time collected from Myers Park Marina, Lansing Harbor, and Ladoga Bay areas.

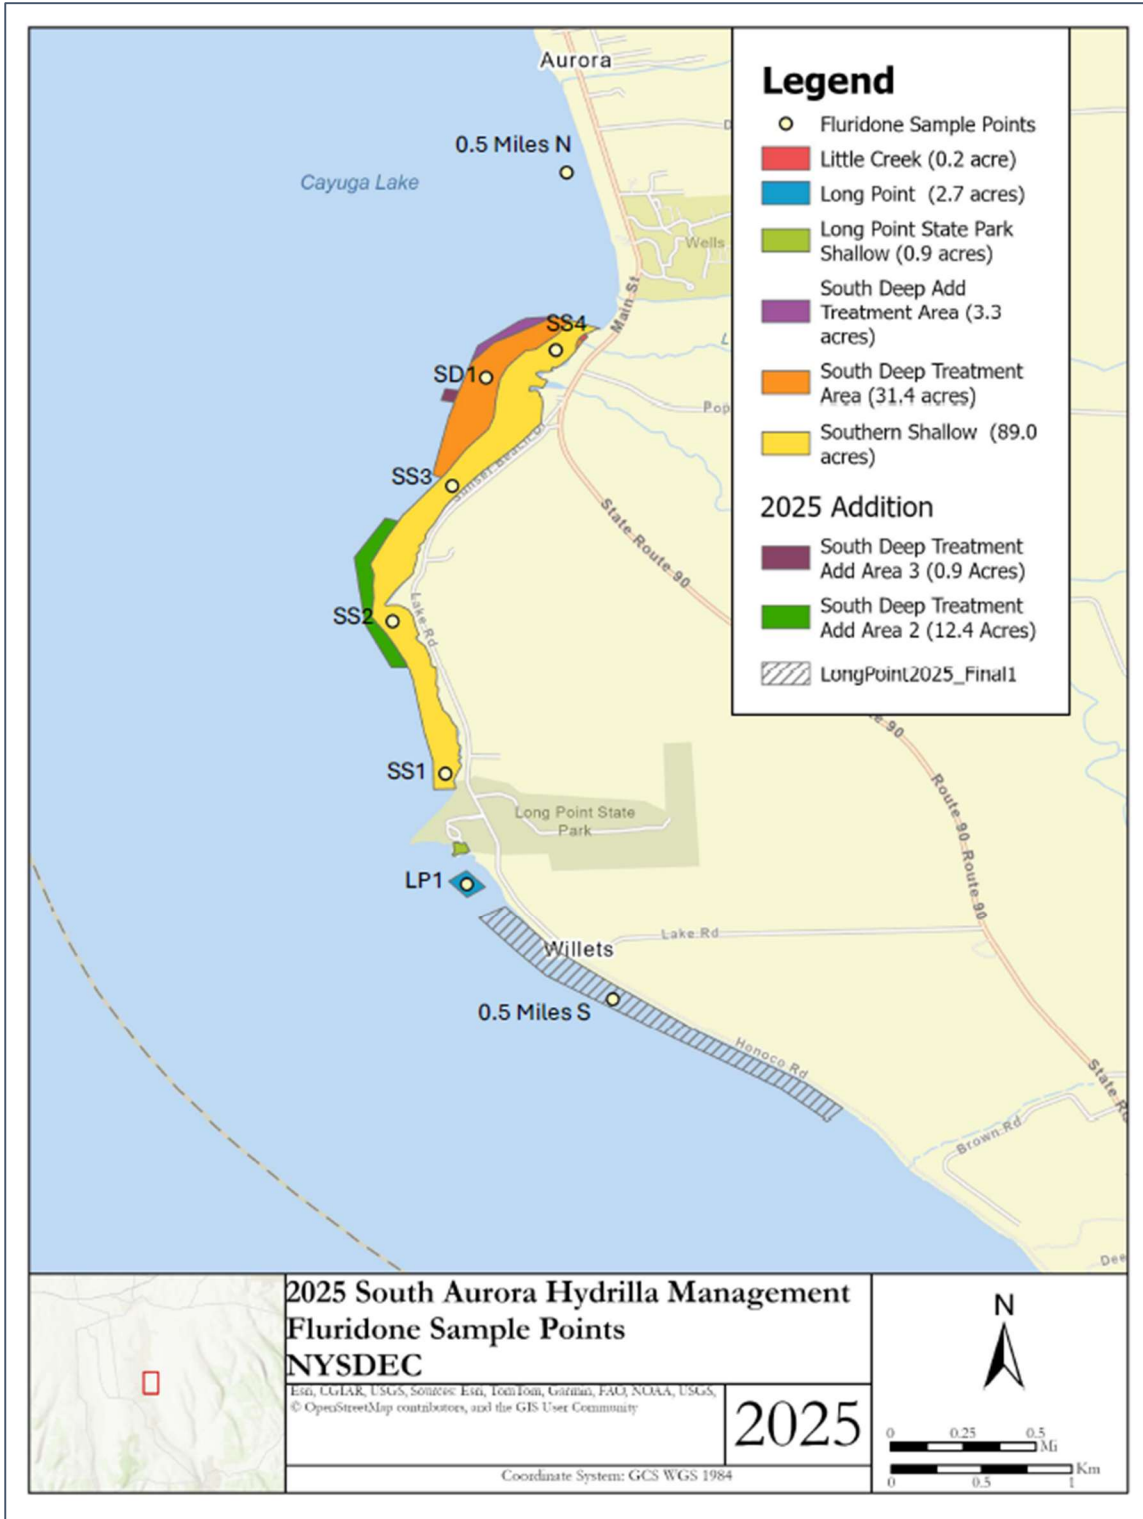
Figure D 5. Map of water sample points collected in the South Aurora area. Water sample results for the reduced South Aurora are depicted in Figure C5.

Table D3. South Aurora fluridone sample results. Samples were collected by Contractor, Little Bear Environmental

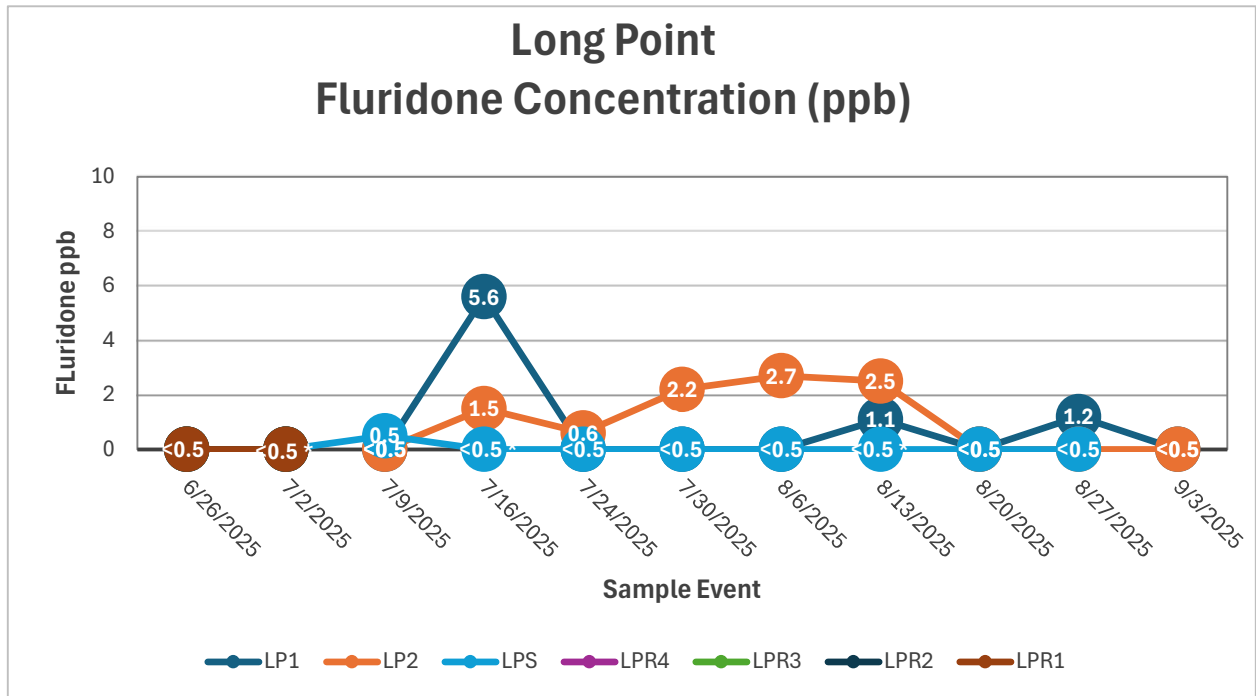
Figure D 3. Graph of fluridone samples at the Long Point Area.
