HABS WEEKLY NEWSLETTER

2022 CAYUGA LAKE HABS MONITORING PROGRAM

September 9, 2022

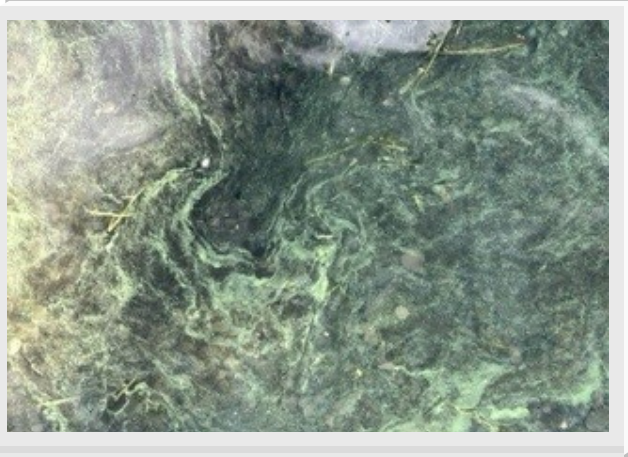
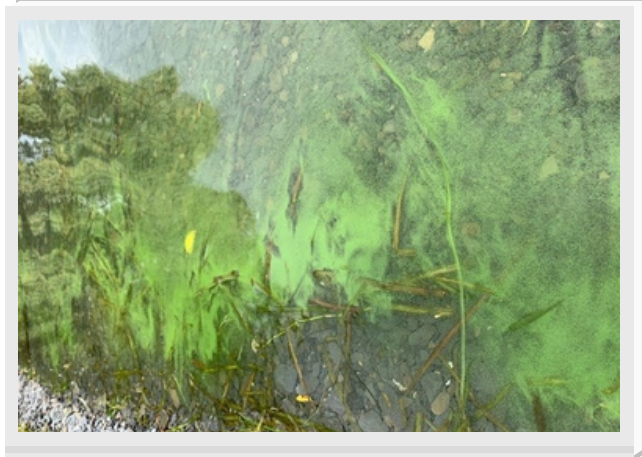
Some of this week's blooms. Photo Credits: Left, Sally Sumner, Right, Harriet Becker. HABs Harriers

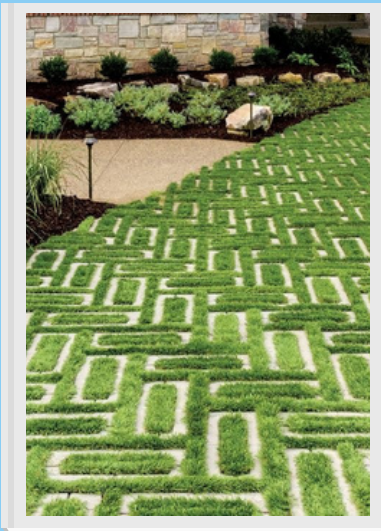
Grass pavers turn an impermeable surface into a permeable one

Consider turning paved spaces back into permeable surfaces, and changing high effort grass lawns into rain gardens or pollinator habitats that don't require fertilizer or mowing.
