HABs Weekly Newsletter

A product of the 2021 Cayuga Lake HABs Monitoring Program

JULY 6, 2021

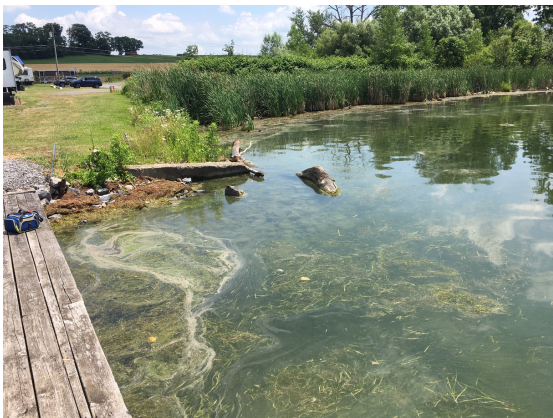
Photo of bloom reported on June 29th.
Image Credit: [CSI Reporting Map](#)

As you can read in the technical chart below, one bloom was reported on June 29th and another only two days later. Considering that both blooms are similar in appearance, microscopy, locations, and reporting time, they are currently being considered continuations of one another, and not originally different blooms.

As Cyanobacteria have been detected in the blooms, please maintain caution as the blooms are potentially harmful. The CSI reporting page will be updated with lab analysis to help make this final determination.

Bloom Code	Date Observed and Sampled	Location Description	Bloom Extent	Microscopy	Total Chlorophyll (ug/L)	Microcystin Toxin (ug/L)	Bloom Status
21-3458-B2	6/29/2021	Near the shoreline of Cayuga Outfitters Marina in the Village of Cayuga.	Small Localized	Dense colonies of Dolichospermum, moderate Microcystis, sparse Limnoraphis, and dense unknown tiny filamentous cyanobacteria.	13,746	Results Pending	Cyanobacteria Bloom (HAB): Cyanobacteria are present in bloom (HAB) sample. Microscopic examination indicates the presence of cyanobacteria and therefore the potential for the bloom to be harmful.
	7/1/2021	Bloom located along the shoreline of waterfront properties on Water St. north of the Village of Cayuga. Bloom reported to be widespread in that northern bay.	Widespread	Dense to moderate colonies of Dolichospermum and Microcystis.	Results Pending	Results Pending	Cyanobacteria Bloom (HAB): Based on field reports and photographs this is likely the continuation of bloom 21-3458-B2 that occurred on June 29, 2021. Results from lab analyses will help make this determination.

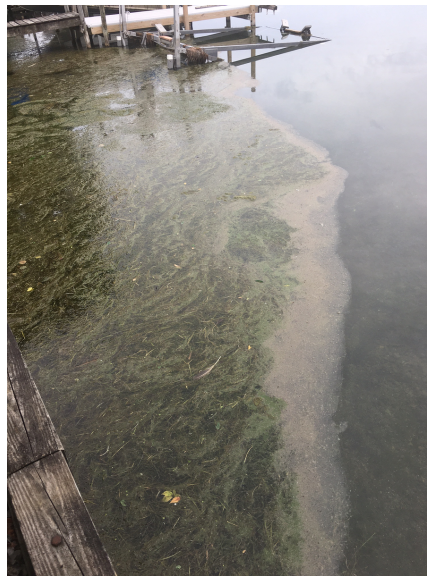
Photo of bloom reported on July 1st.
Image Credit: [CSI Reporting Map](#)

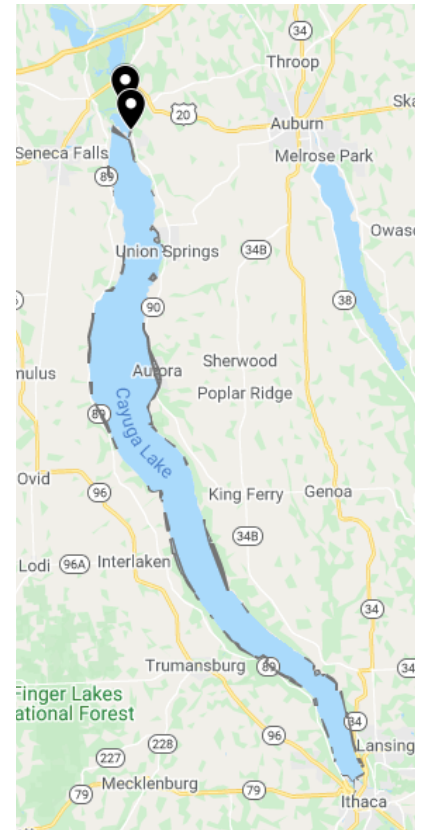
Map Indicating the location of the blooms from the past week (Indicated with the black pins).
Image credit: [CSI Reporting Map](#)

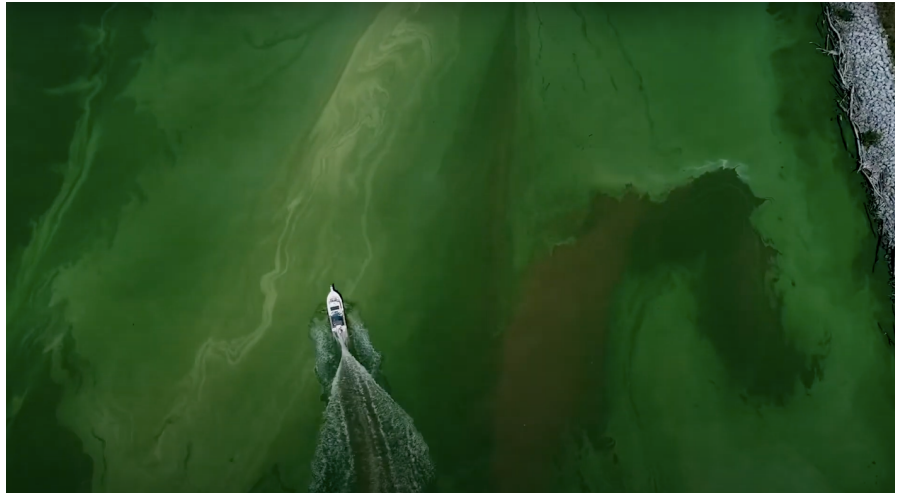
A boat goes through a HAB in Lake Erie during the 2014 Toledo water crisis. For 72 hours residents of Toledo could not use their water because of the a microcystin-producing bloom in the water that directly fed into into the city's intake pipe ([Image Credit](#)).
