# HABS WEEKLY NEWSLETTER

2022 CAYUGA LAKE HABS MONITORING PROGRAM

JULY 21, 2022

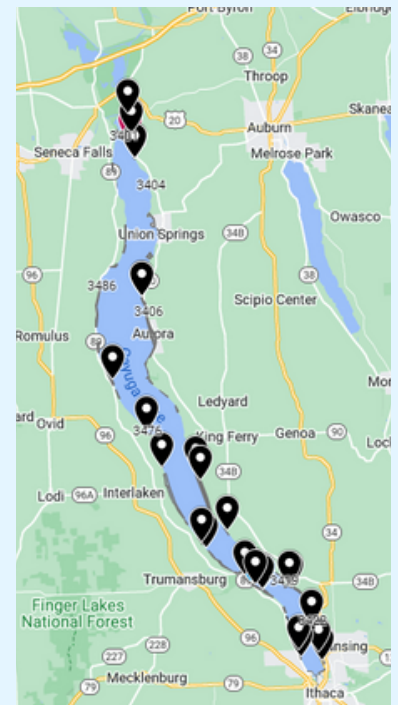
Map of Cayuga Lake indicating the location of HABs.

- Black pins:** Cyanobacteria are present in bloom (HAB) sample
- Red pins:** Cyanobacteria bloom with a microcystin toxin concentration that exceeds the limit for contact recreation (4.0 ug/ L).
- Blue pins:** Suspicious HAB
