HABS WEEKLY NEWSLETTER

2022 CAYUGA LAKE HABS MONITORING PROGRAM

JULY 28, 2022

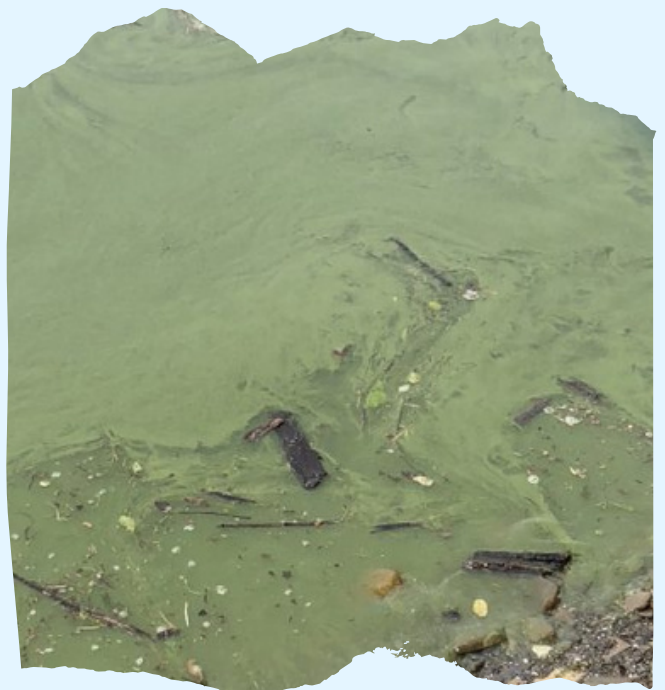
A cyanobacteria bloom (HAB) alongside the shore of Cayuga Lake (image credit: [CSI website](#)).
