## Hydrilla Management in Cayuga Lake: Updates & Panel

December 12<sup>th</sup>, 2024  
Cayuga Lake Nature Center  
1420 Taughannock Blvd, Ithaca

# Region 7 AIS Strike Team 2024 Summary

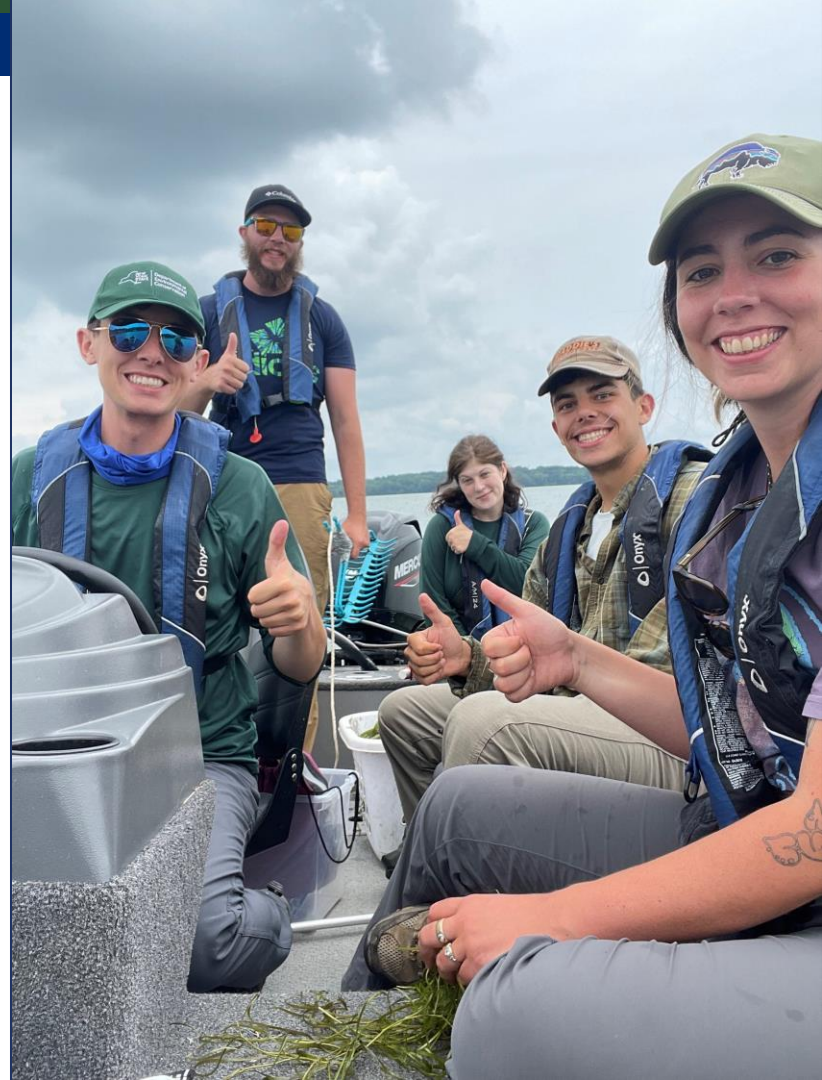
- ~**6230** monitoring Points on Cayuga Lake
  - At least 2 rake tosses per point
- Monitored over **1070** acres of Cayuga Lake
  - ~ 980 acres were monitored twice
  - First round of monitoring occurred Late May – July
  - Second round of monitoring occurred August – October

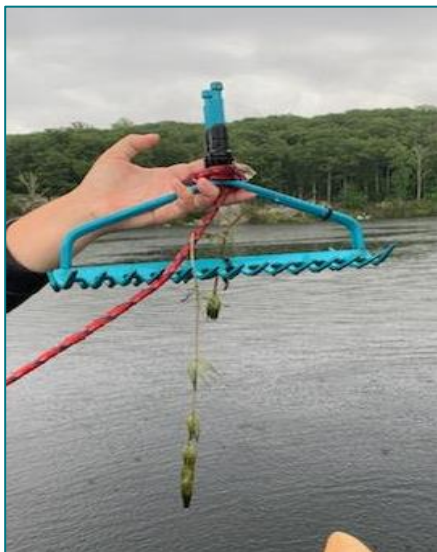
**Trace (1)**

- Point Intercept Survey (PIS) for Submerged Aquatic Vegetation (SAV)
- A grid is used to determine points
  - 50m Grid for early detection sites
  - 25m Grid for known hydrilla locations
- At least two rake tosses are performed at each point on either side of the vessel, with total vegetation density and individual species density collected.
- Density is recorded using the following scale:
  - Zero (0)
  - Trace (1)
  - Sparse (2)
  - Moderate (3)
  - Dense (4)
- SONAR/ BioBase

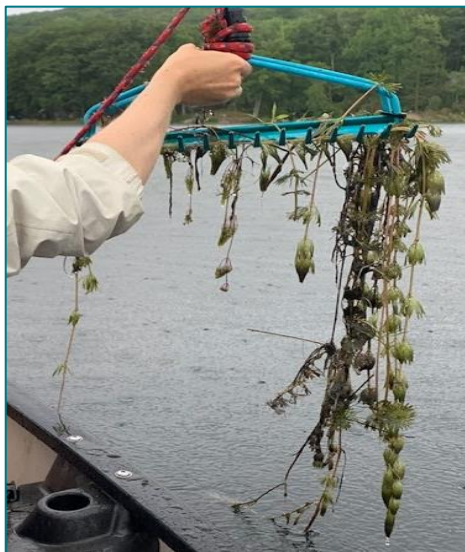
**Sparse (2)**

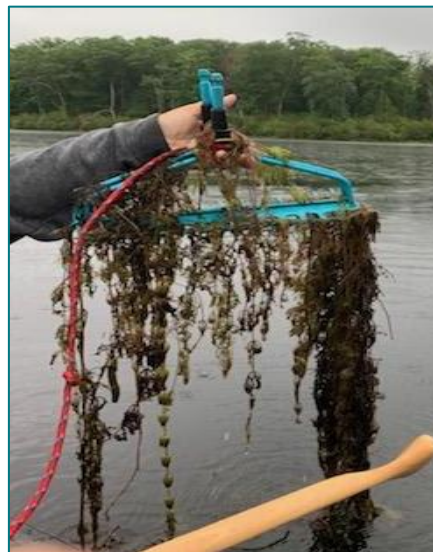
**Moderate (3)**

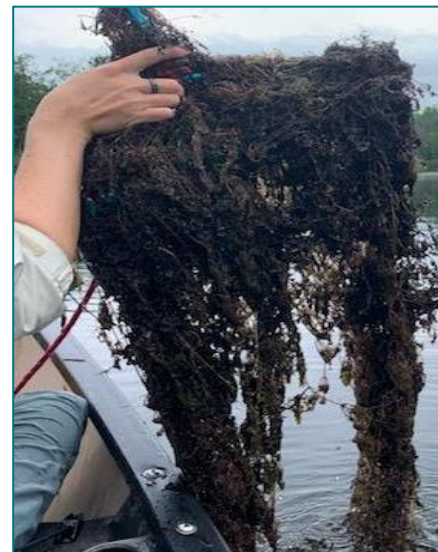
**Dense (4)**

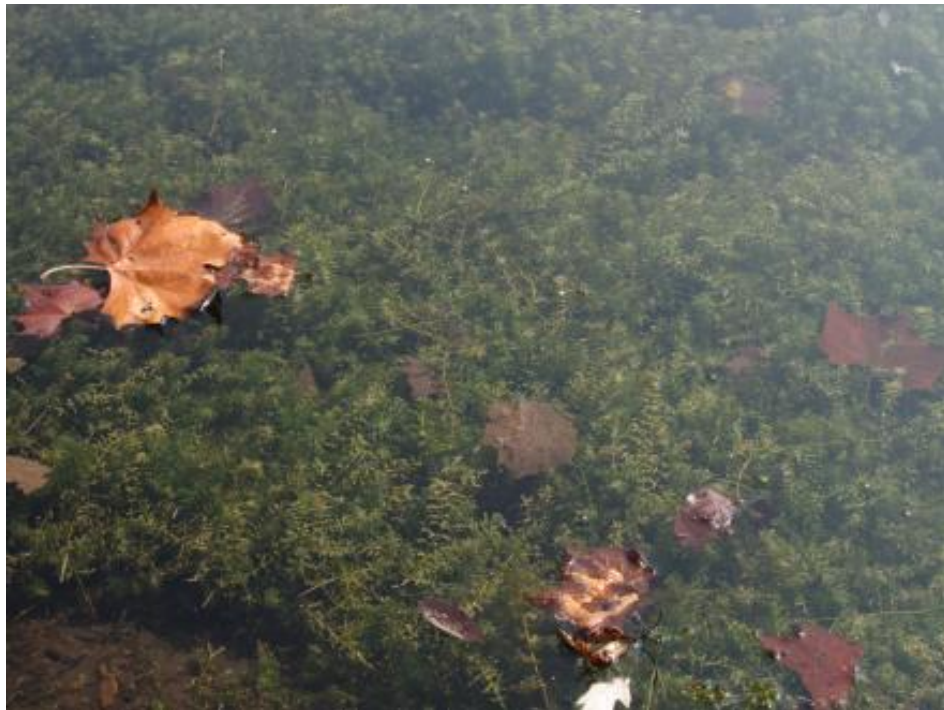
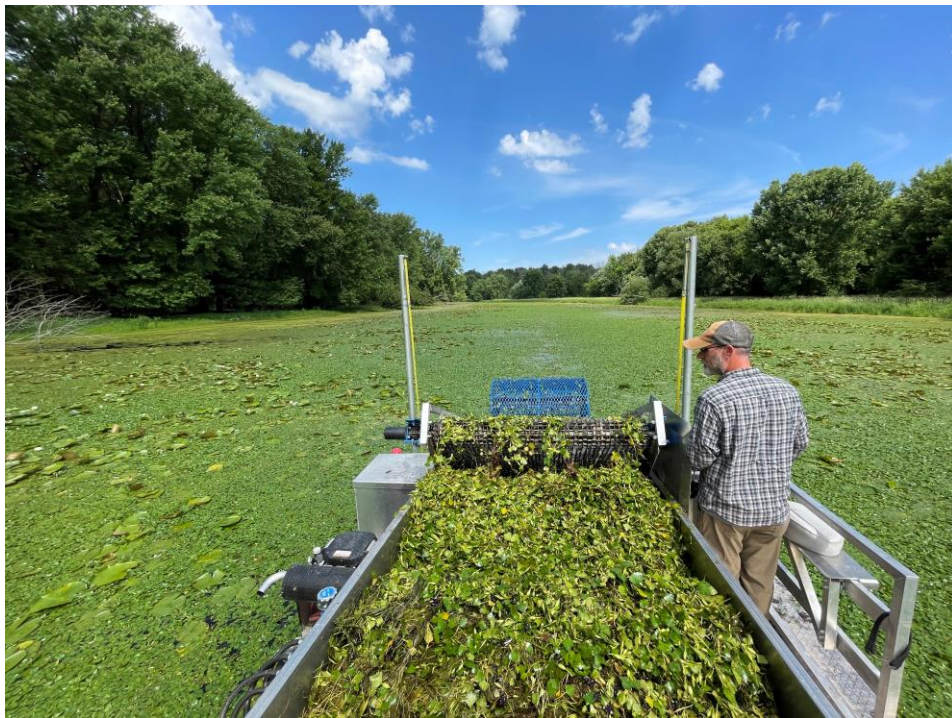
Mechanical Harvesting of Water Chestnut on the Seneca River

- Mechanical Harvesters
- Hydrilla spreads by fragmentation.
- Benthic Barriers
- Diver Assisted suction Harvesting (DASH)/ hand pulling

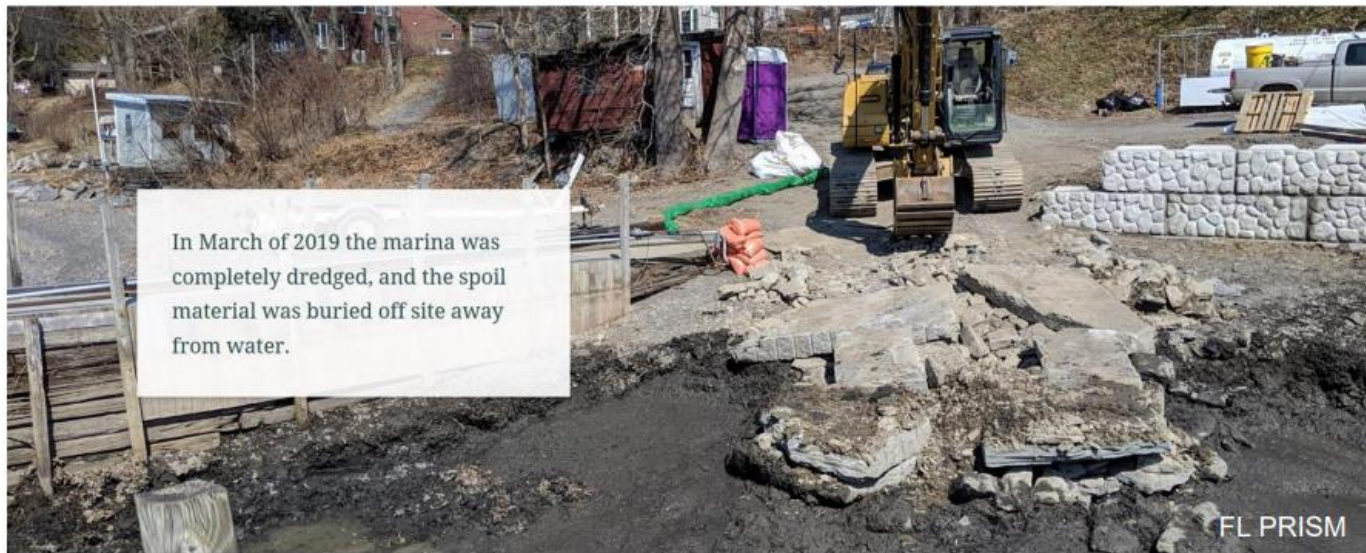
- Dredging
- Can be very successful if done correctly

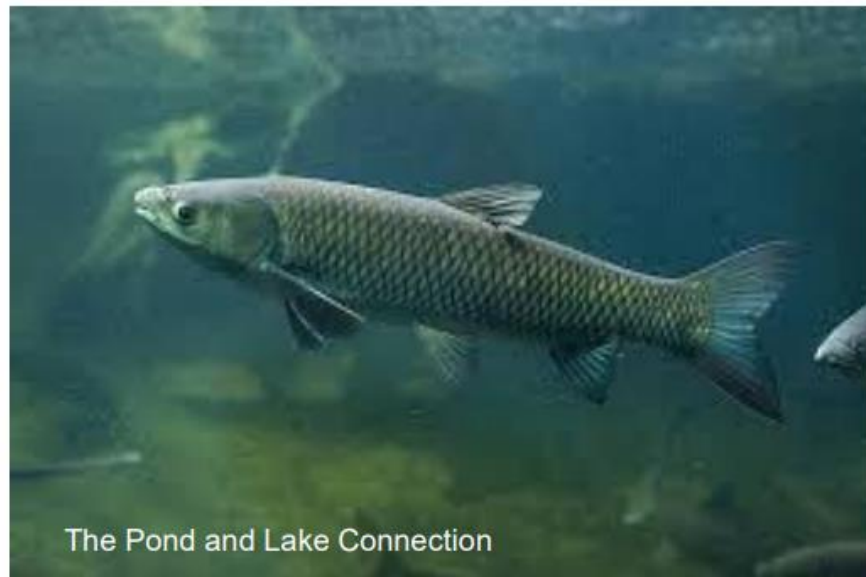
- Triploid Grass carp
- Control aquatic vegetation in small ponds or lakes where fish can be retained within the waterbody
- No other biological control agents are currently available for hydrilla

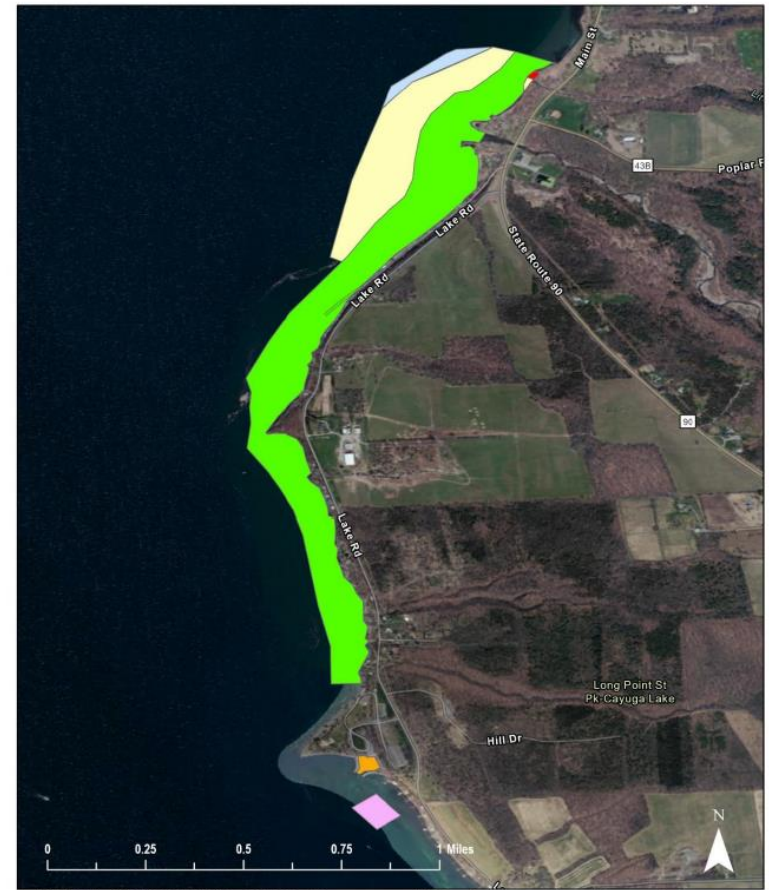
2024–2026 NYS DEC Proposed Fluridone Treatment Areas  
Cayuga Lake, Aurora, NY

- 127.5 Surface Acres
- Management Method: Chemical
- **Sonar H4C**
- Treatment performed by Contractor
- Began treatments on 7/9/24
- Application once a week
- Last application 9/10/24
- Water samples collected after treatment

<span style="color: red;">■</span> Little Creek (0.2 acre)	<span style="color: lightblue;">■</span> South Deep Add Treatment Area (3.3 acres)
<span style="color: pink;">■</span> Southern Shallow 2 (2.7 acres)	<span style="color: yellow;">■</span> South Deep Treatment Area (31.4 acres)
<span style="color: orange;">■</span> Long Point Boat Launch (0.9 acres)	<span style="color: green;">■</span> Southern Shallow 1 (89.0 acres)

Acres		89	2.7	0.2	31.4	3.3	0.9	127.5 ac.
Average Depth (ft)		6.4	9.5	1	7.5	9.1	3.51	
Acre-Feet		569.6	25.65	0.2	235.5	30.03	3.16	864.14

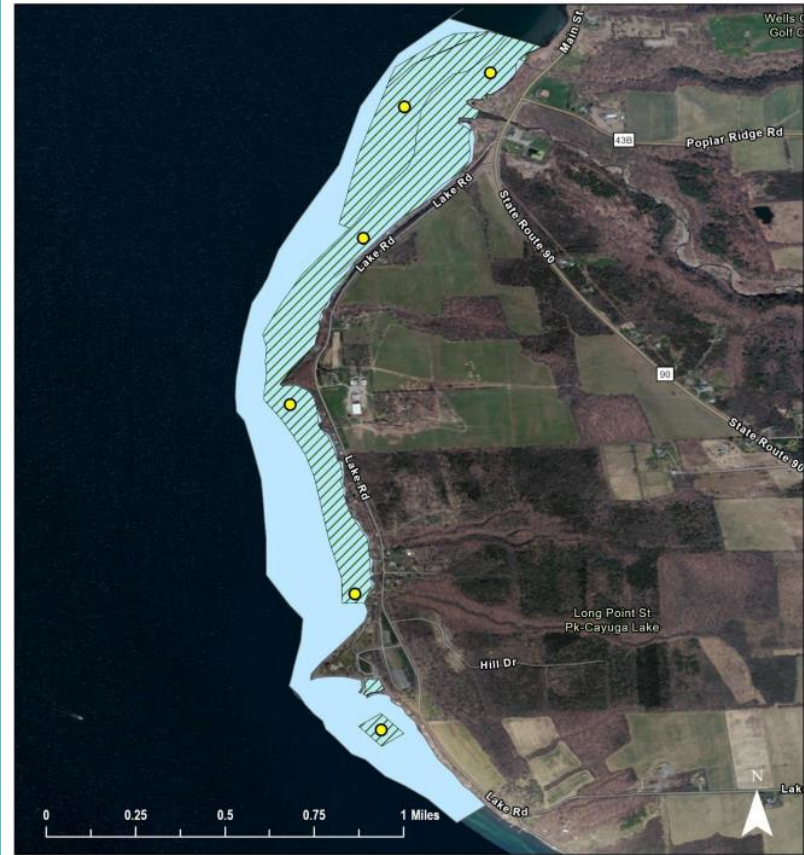
2023 NYS DEC Treatment and Monitoring Areas  
Cayuga Lake, Aurora, NY

- Additional samples 0.5 miles north and south of management area.

- DEC Water Sample Sites (Fluridone)
- ▨ DEC Fluridone Treatment Areas 2023
- DEC Monitoring Area 2023
