What we will lose:

The issues for the watershed:

Increased flood risk and erosion

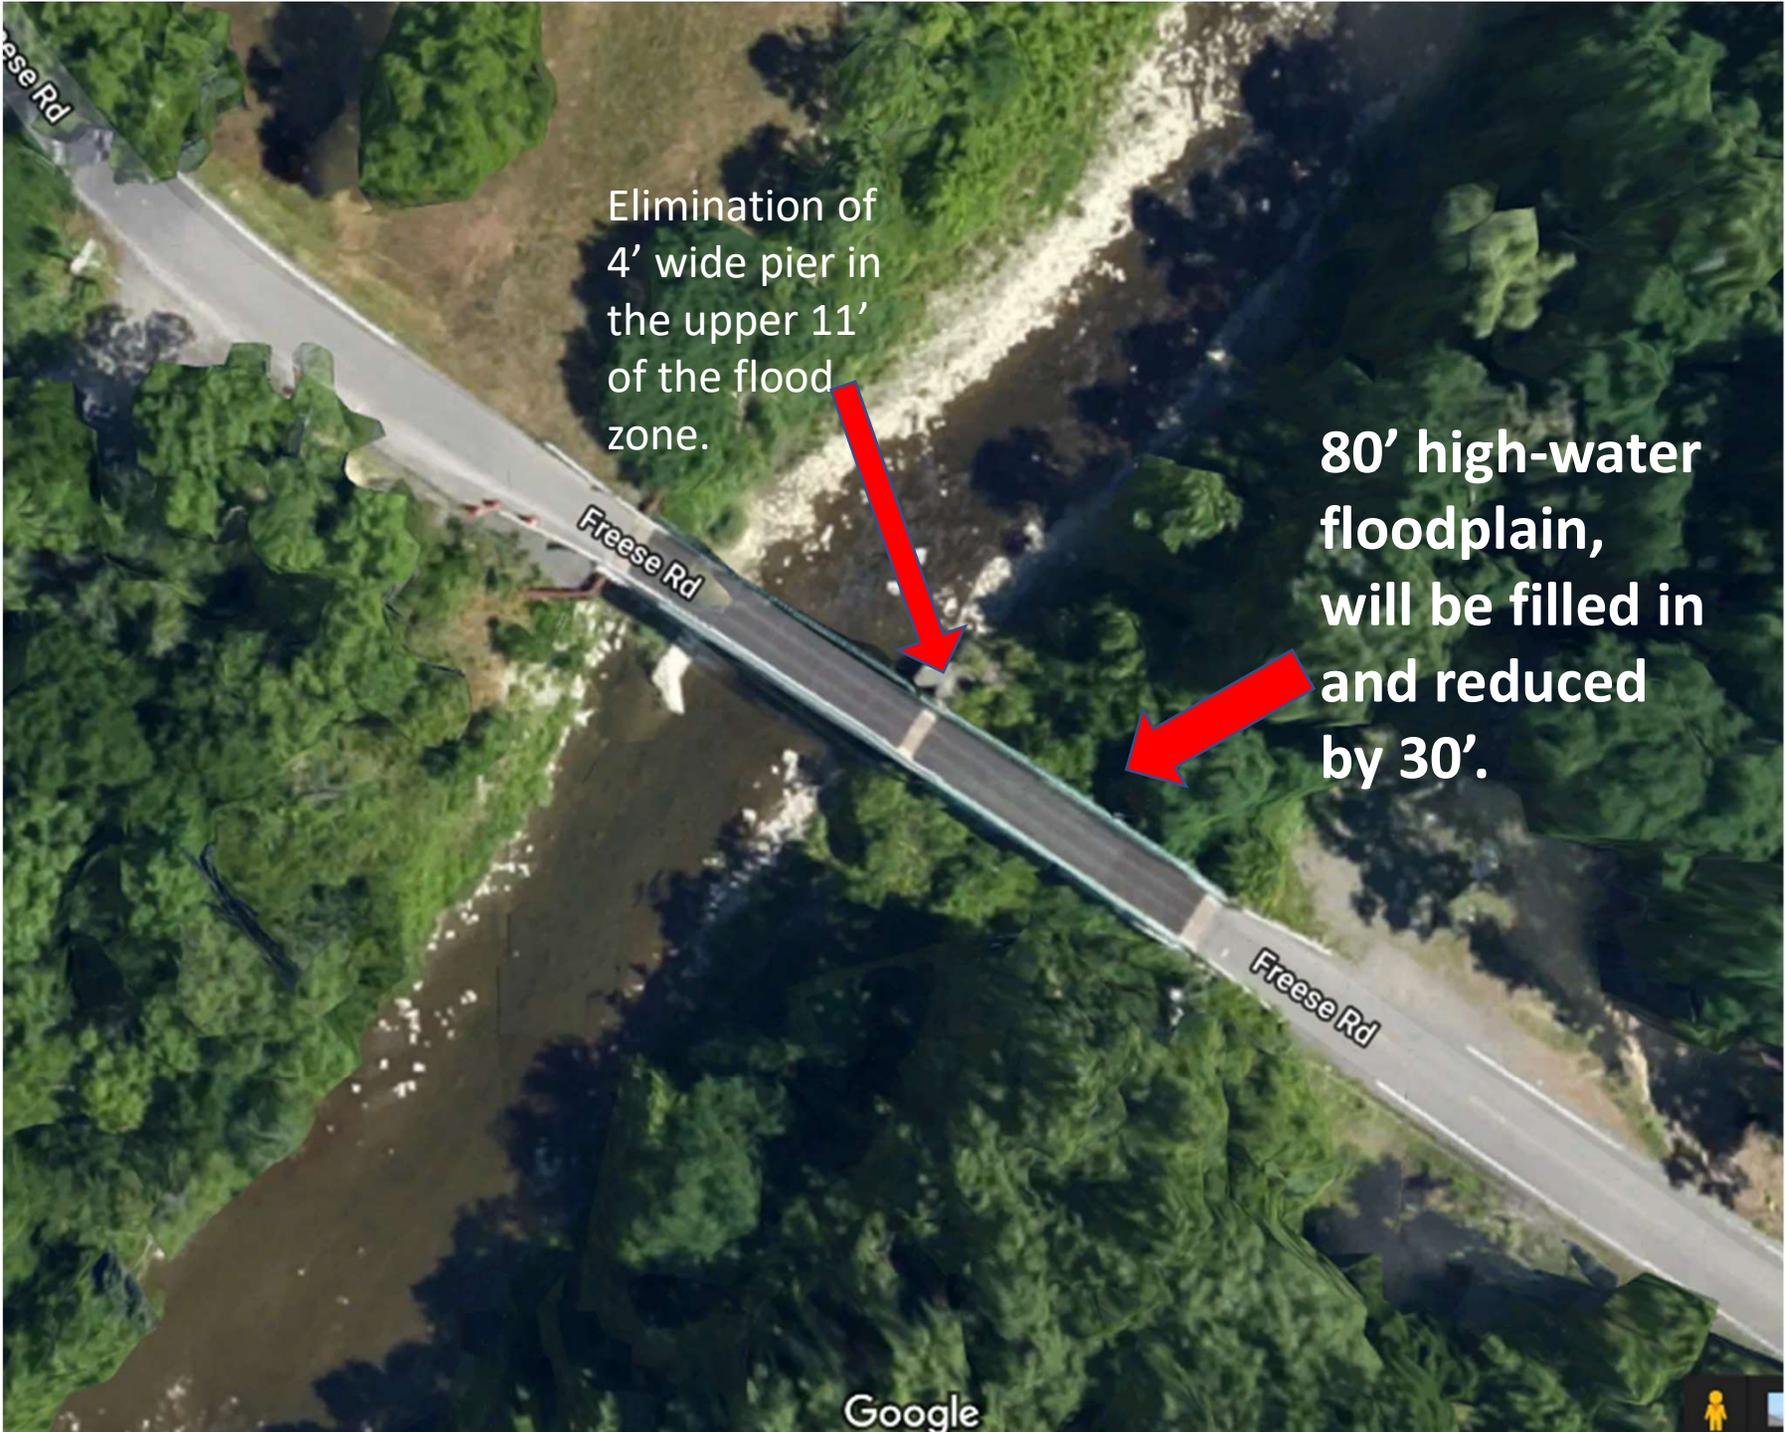
Elimination of
4' wide pier in
the upper 11'
of the flood
zone.

80' high-water
floodplain,
will be filled in
and reduced
by 30'.

- ❖ Replacing the bridge instead of rehabilitating it means **decreasing the flood channel width by 20%**.
- ❖ **Filling in of Federally designated wetland** beneath bridge.
- ❖ Increasing the **height and/or velocity** of water, and **erosion potential** downstream.
- ❖ Increasing the potential for backup and **flooding upstream**.
- ❖ Rehabilitation would **cost the same** as replacement.
- ❖ In the last 20 years, the northeastern US states received **37% more extreme precipitation events**.

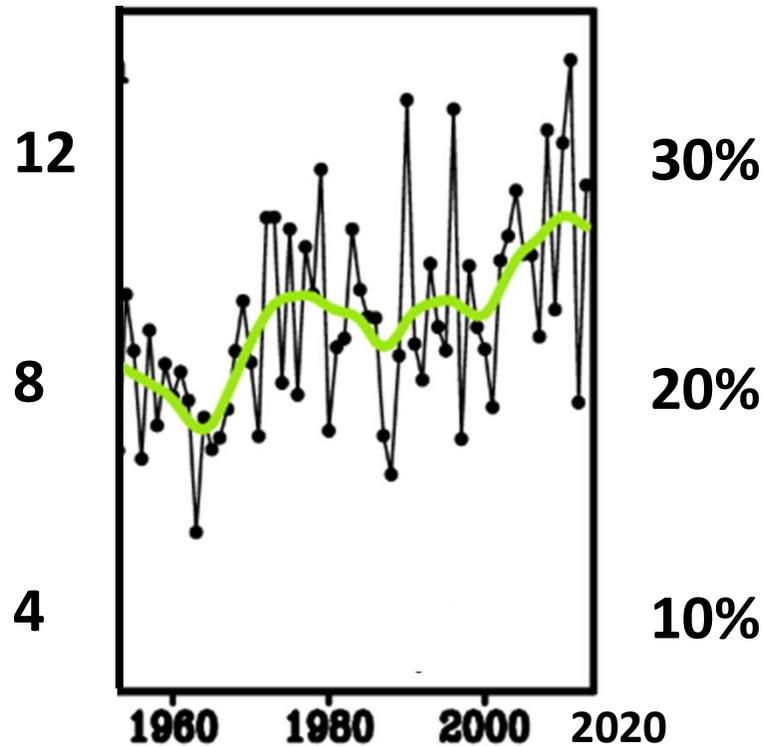
More of our rain is coming in high intensity events

Amount of rain in high intensity events (upper 5% of rainfall events; cumulative inches per yr)

% of rain in high intensity events

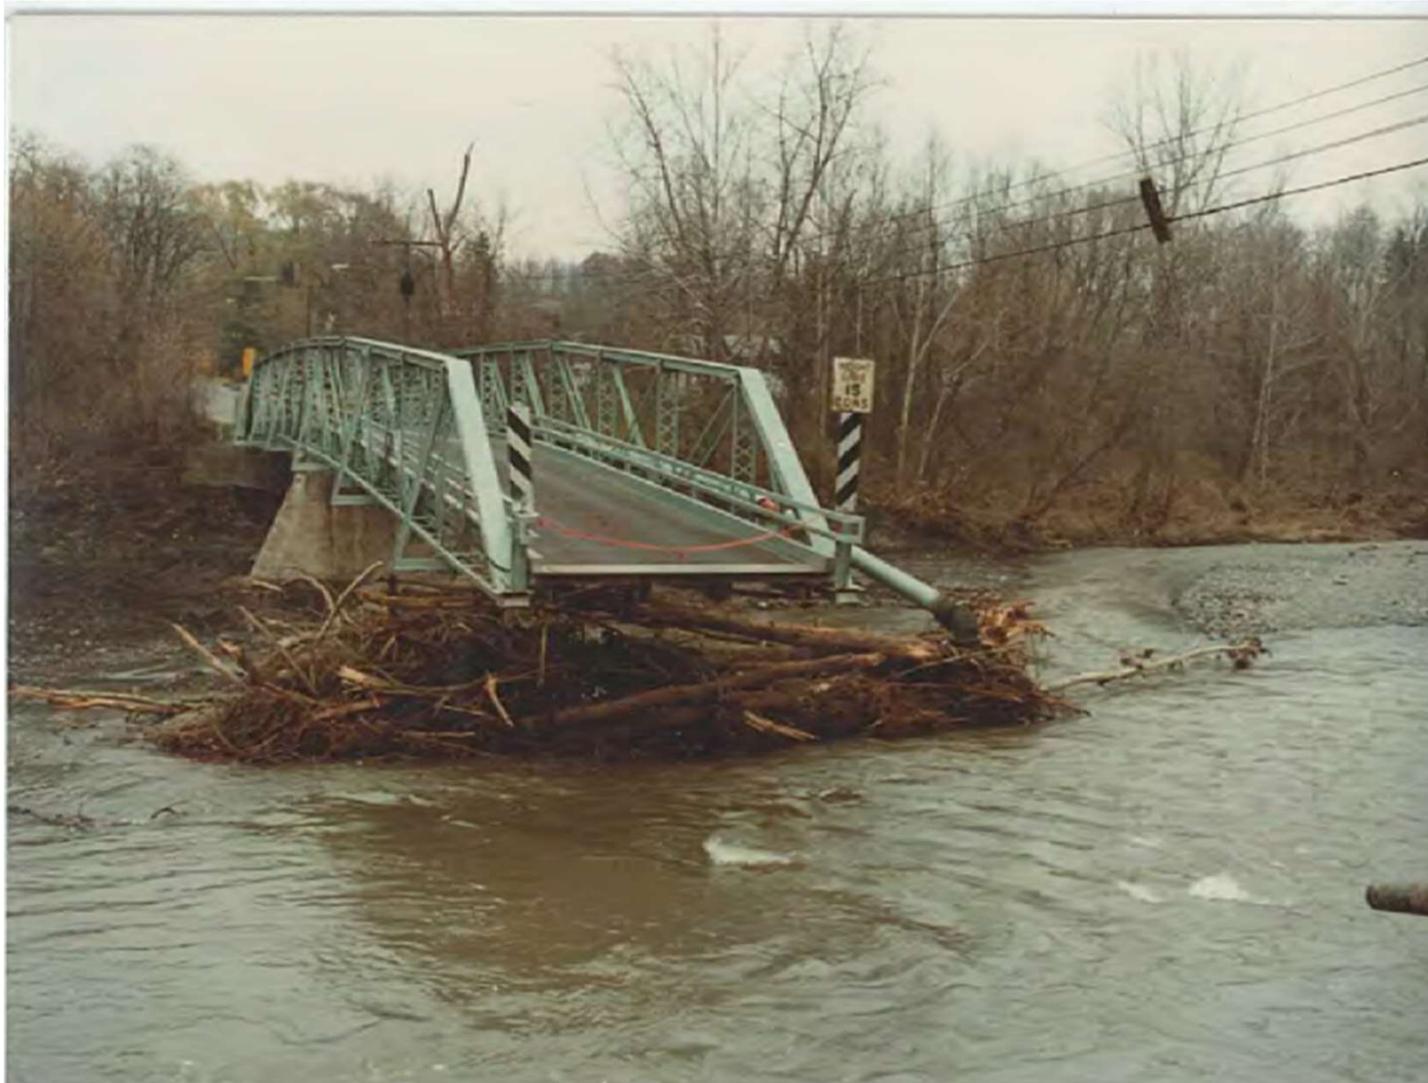
Flood of October 28, 1981

(2.8 feet below the historic Crest of Fall Creek,
Feb 21, 1971)

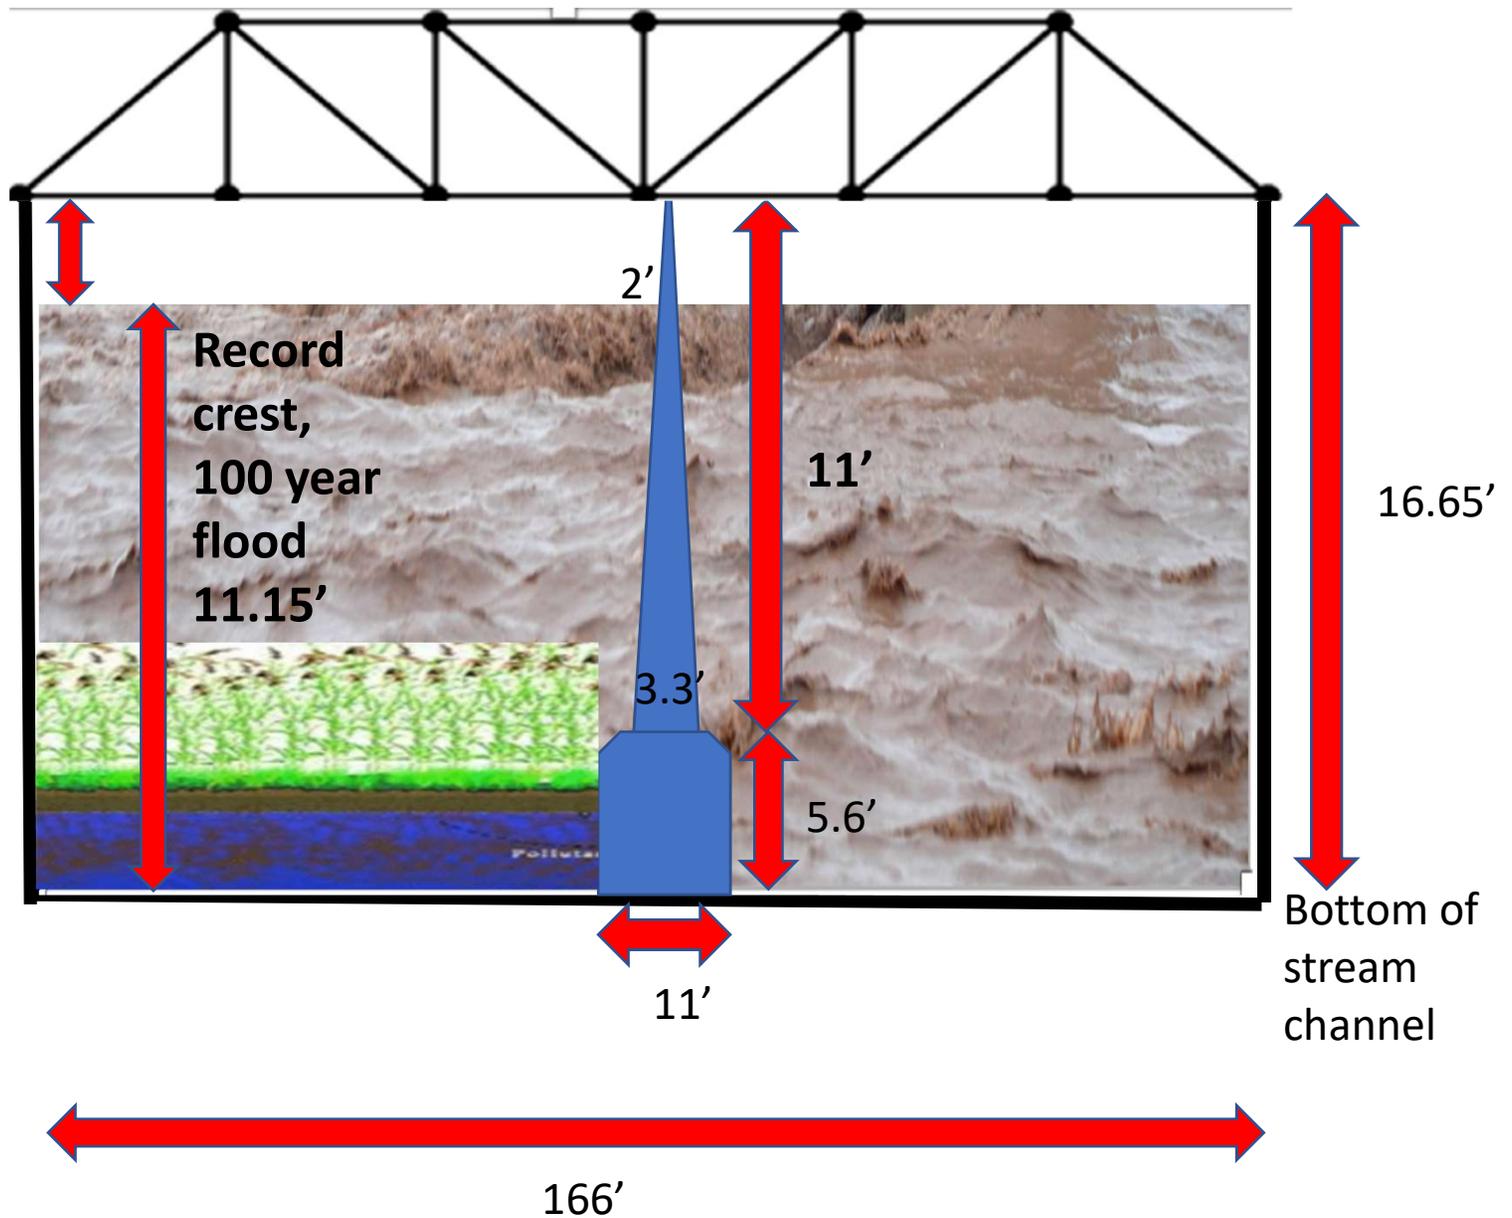
Freeboard clearance = 5.5 ft

Cross sectional area during 100 yr flood = 1673 sq ft

Note: Dimensions not drawn to scale.
Flood height at gage 1 mile downstream.
