Flood Mitigation Needs Assessment

**Six Mile Creek
Tompkins County, New York**

October 2003

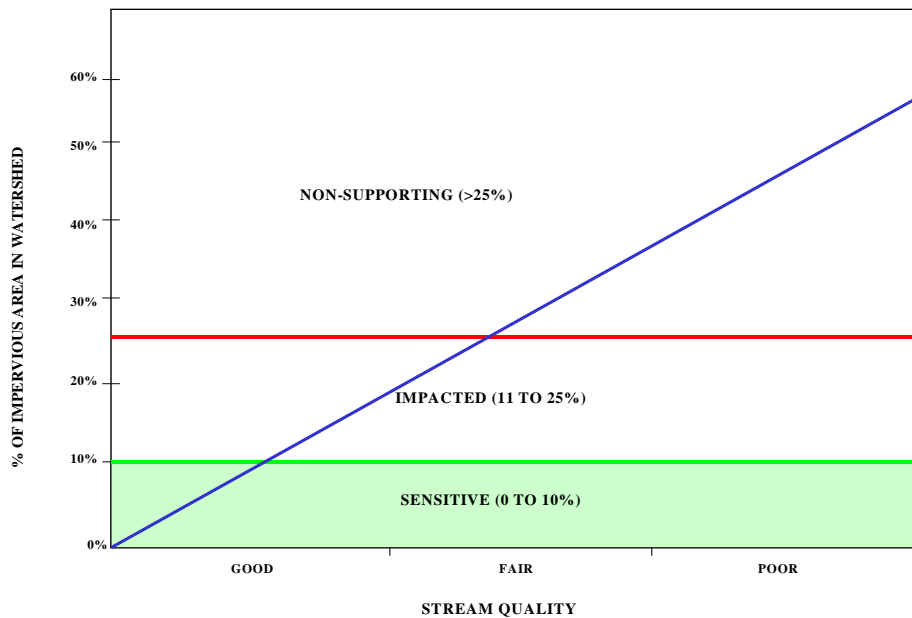
**Figure 4-1
Relationship of Imperviousness to Water Quality**

Source: Schueler & Claytor, 1996 ASCE

Detailed studies of numerous watersheds have shown that the physical, biological, and chemical (water conditions) usually deteriorate as the watershed becomes developed. The percentage of the watershed covered with impervious material such as rooftops, parking lots, roadways, and driveways is often used as an indication of urbanization. Research has demonstrated the following relationships between watersheds impervious cover and the streams condition. (Center for Watershed Protection, 1998) This information provides an initial method to rapidly assess watersheds susceptible to change.

Streams with 10 to 25 percent impervious cover usually are impacted with erosion channel deterioration, unstable banks, reduced habitat, reduced biodiversity, and declining water quality. Streams within watersheds of over 25 percent impervious cover tend to be flood prone, highly unstable, with poor water quality and limited aquatic life. Figure 4-1 illustrates the relationship between impervious cover and stream quality, information that can be used to categorize streams as sensitive, impacted, or non-supporting.

The water quality of the sub-watersheds within Six Mile Creek as observed in the field and indirectly assessed using the impervious cover metric, is generally quite good. The only sub-area with high impervious cover and extensive storm drainage is WS-10, and to a lesser extent WS-20 and 30. Consequently, except in the City of Ithaca, watershed urbanization is not a significant factor in the health of Six Mile Creek.
